Listed in order of priority. Most projects reflect a HIGH PRIORITY status from MS4 inspections, while others have been identified by other means. Prioritization takes into account the following factors: Condition, relative stability of condition, location, consequence of failure (public safety, safety of structures, impact of failure on public, emergency access, etc.), construction disruption and difficulty, and probable cost.

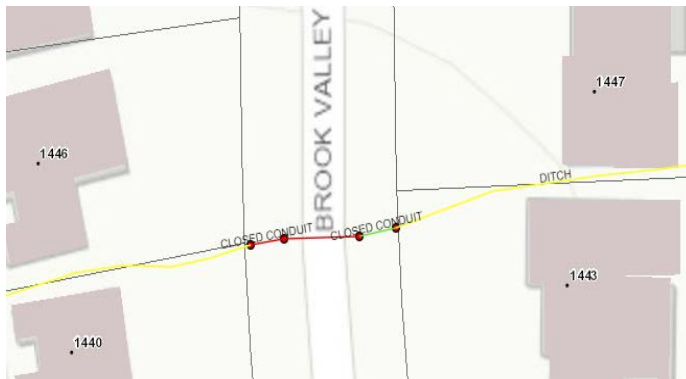
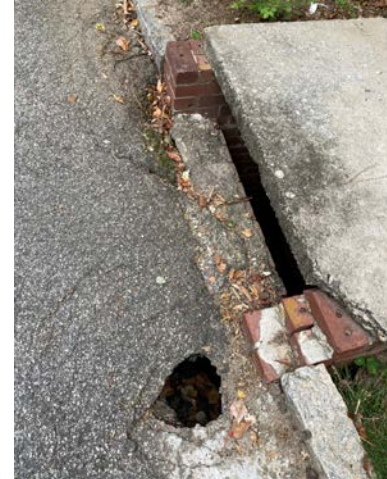
- 1. Brook Valley Ln Drainage Rehabilitation.** *Priority: HIGH.* There are two areas on Brook Valley Ln with similar pipe/structure issues, therefore, this will be treated as a single project.

Area A is located near 1443 and 1440 Brook Valley Ln. A sinkhole has developed in the pavement in front of the east (U/S) CB (FID 21234) at 1443 Brook Valley Ln. The CB is a non-standard square concrete top with no access. The location of the sinkhole signifies some type of failure of the RCP (FID 31149) under the road. The inspection photo shows the pipe out of alignment. The D/S CB (FID 21221) is also a non-standard square concrete top. Replacement of the pipe may necessitate the replacement of both structures and tops. New GDOT Type 1033 structure tops should be installed. The RCP discharge pipe (FID 31019) from the CB and the HW demonstrate disrepair by erosion and should be repaired/replaced with a mitered end section. Energy dissipation measures should be installed on the D/S side.

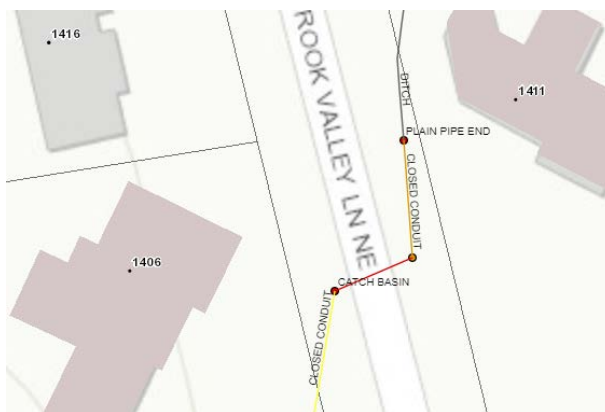
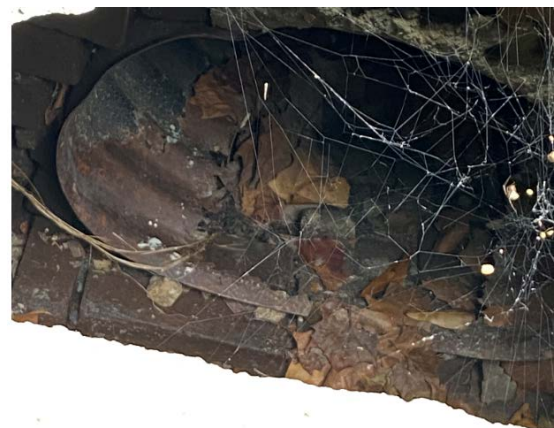
The second area, Area B is located south on Brook Valley Ln. CB (FID 21223) is of masonry construction and the square concrete top is too large for the CB. The mouth/throat of the CB appear to be too small, as seen by sediment accumulation in the gutter. From the east is a 8” terra cotta pipe (FID 31111), and to the west is a bituminous CMP (FID 31110), possibly an arch pipe (15” x 21”) or a partially crushed round pipe (24”). The flowline of the pipe is corroded and requires replacement. The D/S CB (FID 21215) is brick masonry structure with a square top. Both structures should be replaced with larger throats and GDOT 1034 tops. The D/S RCP should be inspected with CCTV. The inspection photos indicate the 18” RCP is out of alignment and may have displaced joints.

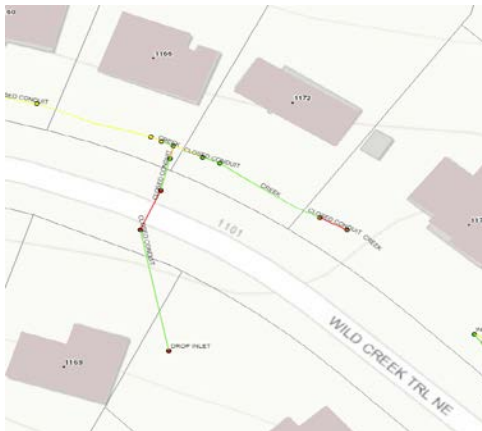
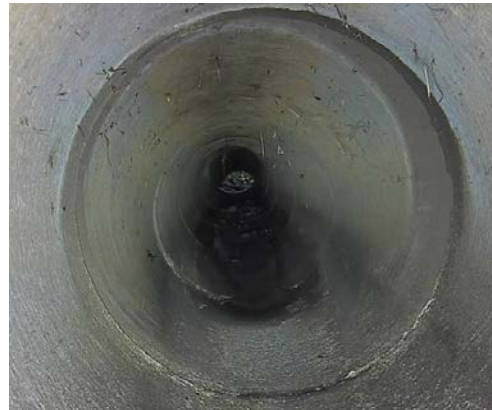
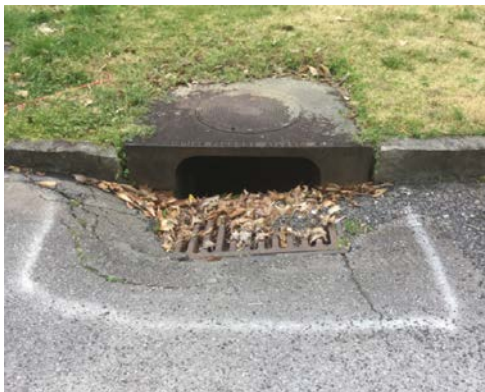
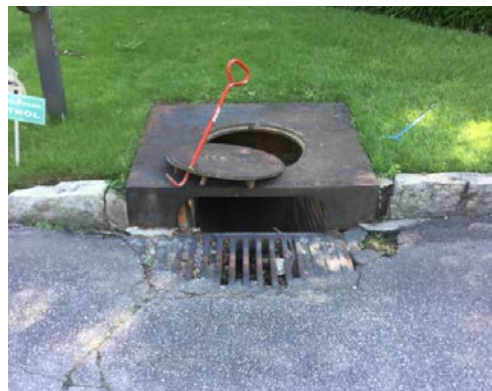
2. **1169/1166 Wild Creek Trl Drainage Rehabilitation.** *Priority: High.* The RCP culvert (FID 31189) under Wild Creek Trail at these addresses is misaligned. Gaps in the joints appear to be present, and the alignment is wavy. At the upstream CB (FID 21270), a cast iron hood inlet, subsidence in the pavement is present, indicating a loss of backfill material adjacent to the CB. The pavement in front of the D/S CB (FID 21273), also a CI hood inlet, also shows signs of subsidence and is in a progressive failure mode. Both inlets and tops should be replaced with standard GDOT structures and tops. The pipe foundation soils should be rebuild, and the RCP pipe should be repaired / relaid in a straight alignment with consistent slopes. The trench should be backfilled and compacted.

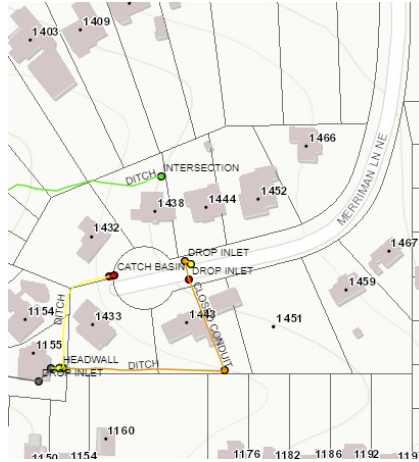
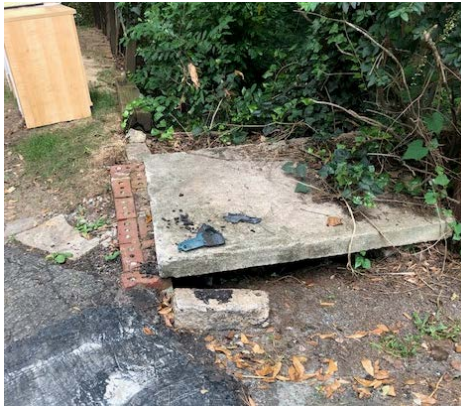
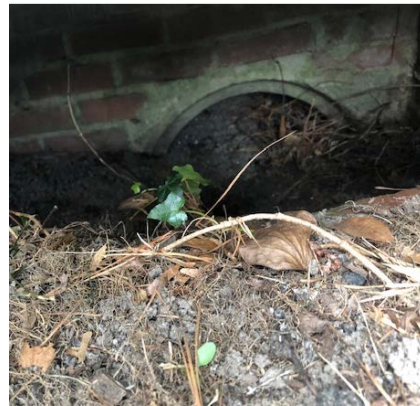
3. **Merriman Lane Drainage Rehabilitation.** *Priority: High.* Two small inlets (east CB: FID 15714 and west CB FID 21277) drain the lower part of Merriman Ln. Each are

undersized and have no access for inspection or maintenance. The 18” culvert under Merriman is over ½ full with aggregate and other debris. The CB on the opposite side of the street is buried. The culvert at the west end of the street is buried and inspection / maintenance are not possible. Both sets of structures and pipe should be replaced with 18” RCP and median inlets.

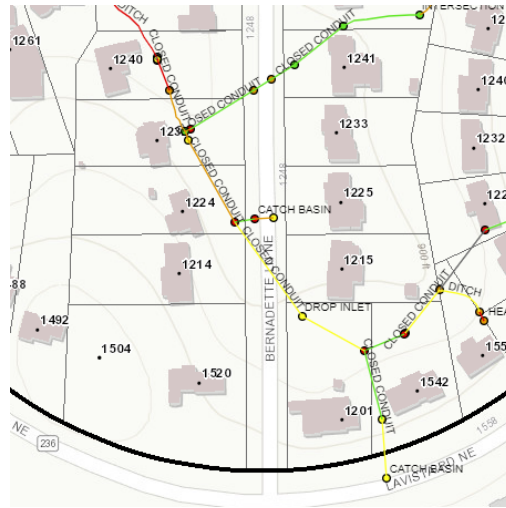
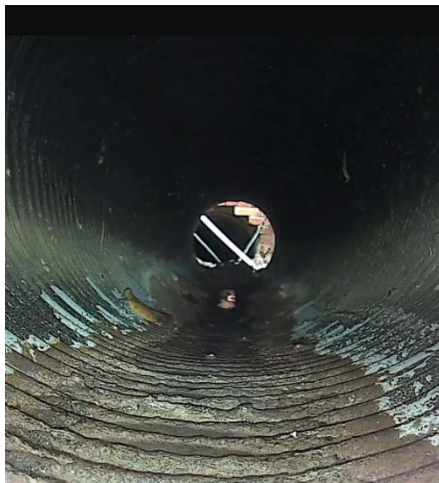
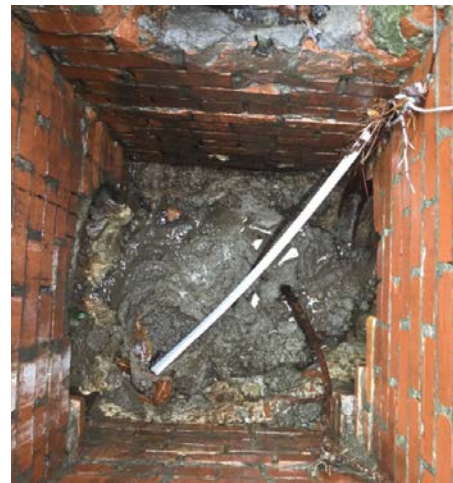
- 4. Bernadette Ln Drainage Rehabilitation.** *Priority: High.* The catch basin (FID 21261) at 1224 Bernadette Ln is dilapidated and requires replacement. The bituminous coating on the CMP cross culvert (FID 31187) has worn off allowing surface corrosion to grow.

In places the corroded CMP is pitted/has holes in it. There is a belly in the downstream side of the pipe indicating subsidence or bedding/backfill erosion. The pipe should be replaced or lined. The upstream structure too should be replaced with standard GDOT structures, throats and tops.

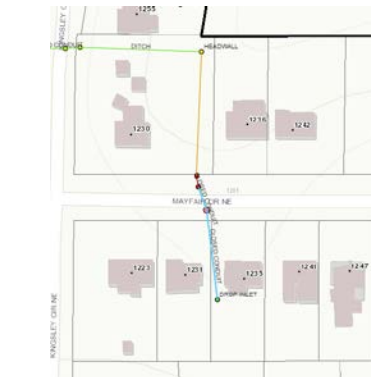
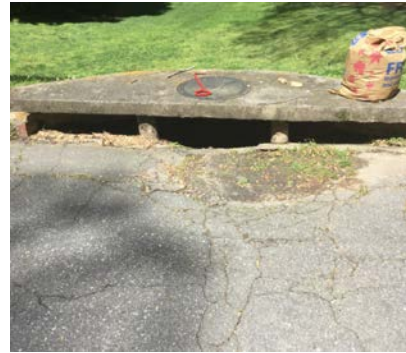
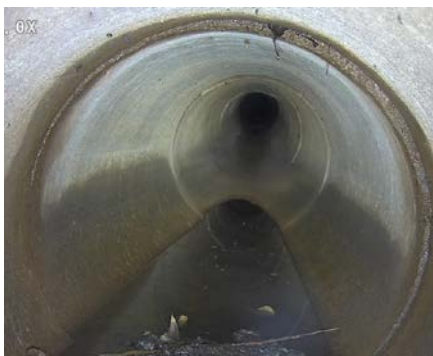
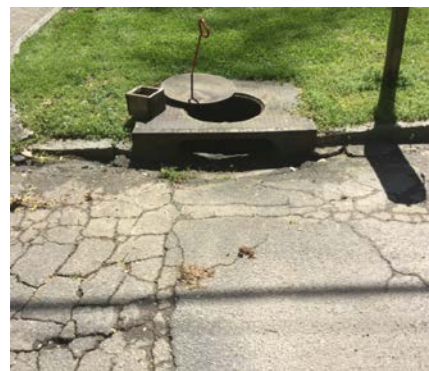
- 5. Mayfair Ln Drainage Rehabilitation.** *Priority: High.* The pavement area in front of catch basin (FID 21211) at 1230 Mayfair Ln exhibits signs of base, bedding, and/or pipe failure. Both the catch basin and the RCP (FID 31086) cross culvert require replacement / rehabilitation. The RCP appears to be in good condition, but there appears to be joint separation that should be rehabilitated. CIPP lining may be a good

candidate for rehabilitation of the RCP pipe culvert. The CB should be replaced with a GDOT standard structure. The discharge pipe and end section should be

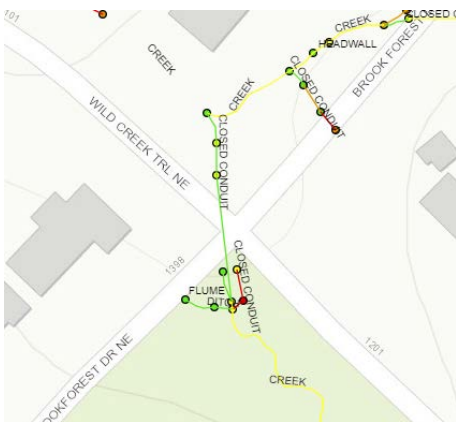
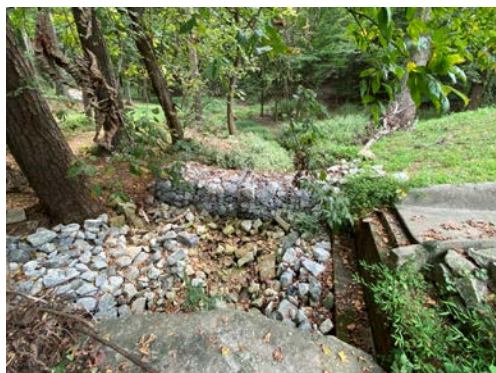
6. **LaVista Park Discharge Weir Rehabilitation.** *Priority: Medium.* The area around the weir over the creek at the north corner of LaVista Park (Wild Creek Trail at Brook

Forest Dr) in LaVista Park has eroded and requires rehabilitation. The weir was installed by DeKalb County several years ago but not maintained.
