# Quarterly Dam Inspection Report

Murphey Candler Park Dam, City of Brookhaven

December 14, 2020

## Embankment (Earth) Dam Inspection Form

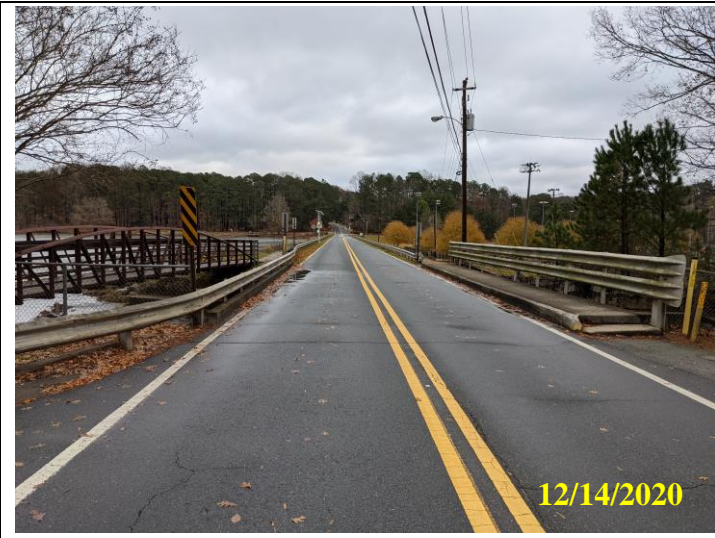
If yes, describe the condition (for example, good condition, numerous cracks, newly paved)/Corrective Action: The road is functional and in good condition (See Photos 1 and 2). Some minor cracks were observed on the paved road at a few locations as described in section 5 of this report (See Photos 3- 5).

1. Standing on crest of dam looking towards left abutment

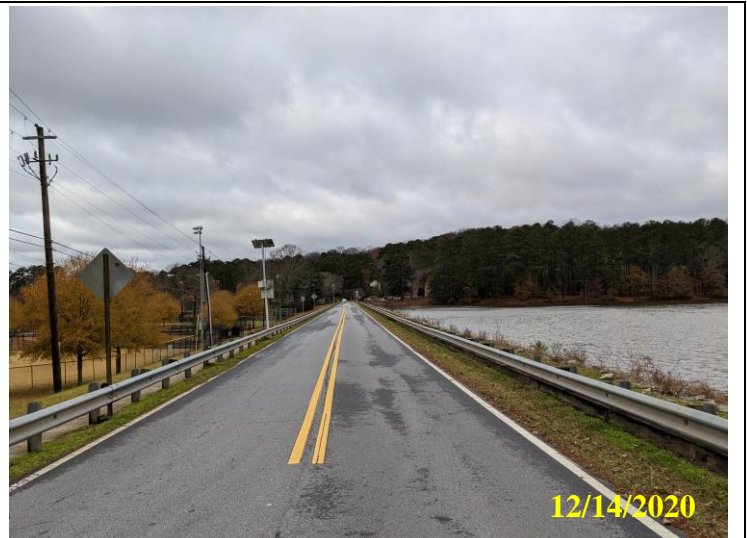
2. Standing on crest of dam looking toward right abutment

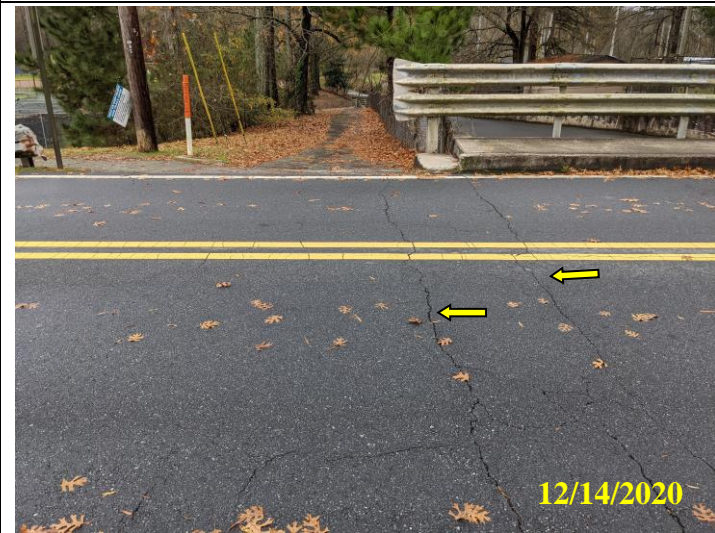
If yes, describe (length and width, location, direction of cracking, etc.)/Corrective Action: The cracks in the paved road on the dam crest noted most recently in the September inspection remain. There is no indication they have grown wider. Existing cracks located on the left end of the bridge measuring approximately 17-ft and 13-ft in length (See Photo 3) are similar in appearance to last inspection. A crack in the centerline of the roadway running parallel to the direction of the dam was also observed near the left (east) end of the dam. This crack should be monitored to ensure it does not increase in size or otherwise worsen. (See Photo 4). Depressed area at the left, downstream edge of the dam crest has created a semi-circular crack in the pavement. (See Photo 5). All cracks appear to be unchanged since September inspection. These cracks should be monitored to ensure they do not increase in size or otherwise worsen.

3. Cracks in paved road on dam crest at left bridge abutment.

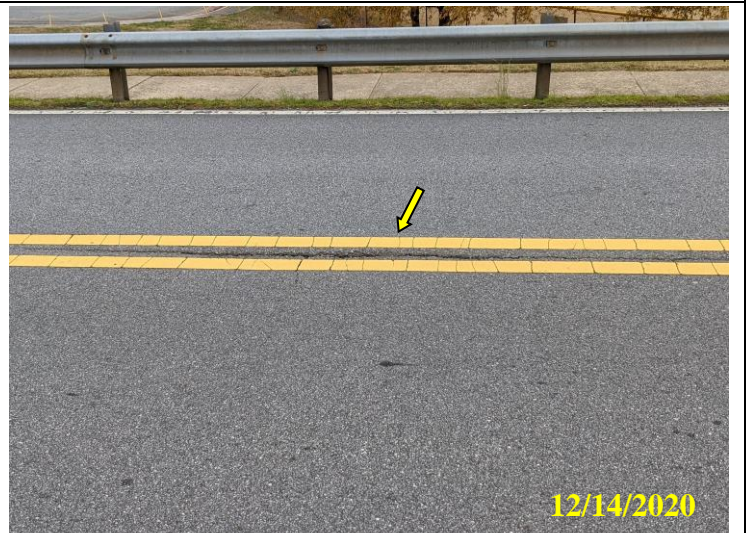
4. Additional crack in paved road on dam crest.

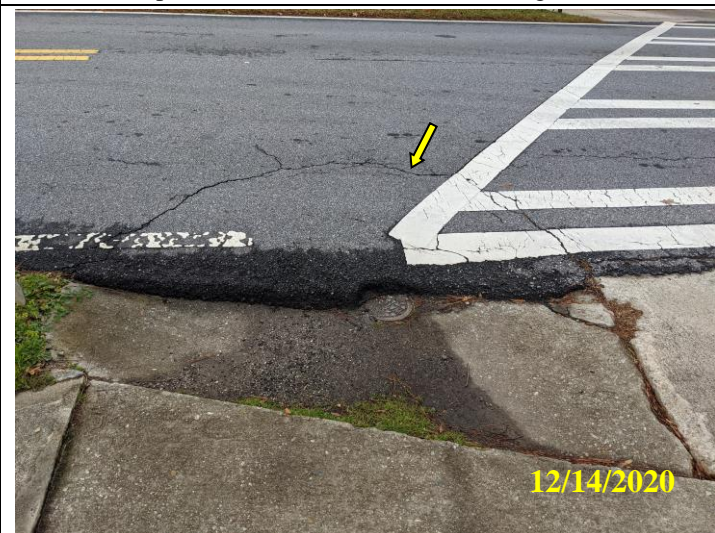
If yes, describe (size, location, etc.)/Corrective Action: There is a minor depression at the downstream left side of the crest by the end of the road guard rail. This depression appears unchanged since the previous report in September. (See Photo 5). Cracks remain in the concrete sidewalk pavement and the asphalt road at this location. These do not appear to be in any area of critical concern but should continue to be monitored.

5. Depressed area on dam crest with crack on road pavement

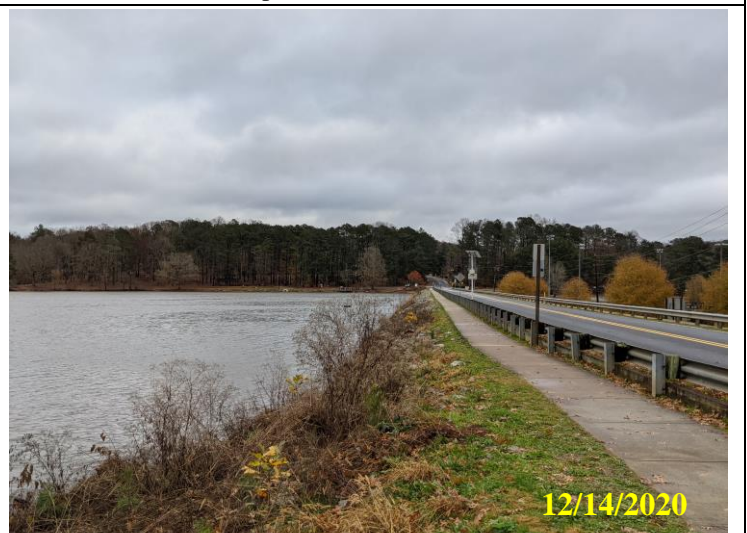
Other/Corrective Action (describe): The upstream slope is primarily covered with unevenly distributed riprap and vegetative growth. The vegetation on the upstream slope was noticeably sparser than September inspection, although this appears to be due to die back from recent low temperatures as opposed to maintenance performed to remove vegetation. (See Photos 6 and 7).

6. View of upstream side looking towards left abutment.

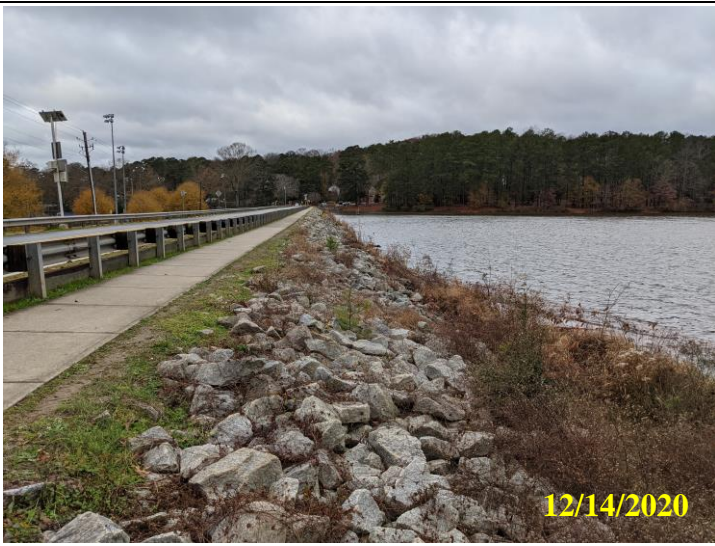
7. View of upstream side looking towards right abutment

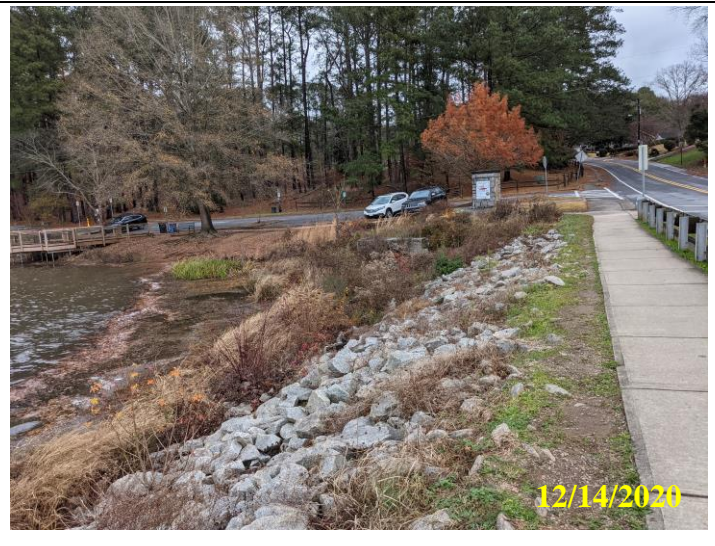
8. View of vegetation on the upstream face of the dam

If yes, describe (type of vegetation, size, location, etc.)/Corrective Action: Woody vegetation remains that should be removed. This vegetation has in some cases dropped its leaves but will likely resume growing in warmer temperatures unless removed. (See Photos 8 and 9). Several young trees reported in the July inspection have not been removed and continue to grow. (See Photo 10). As more vegetation is allowed to take root and mature on the upstream face of the dam the potential for damage caused by roots is increasing. It is recommended that woody vegetation and saplings be cut down to the base or extracted from their roots to prevent growing back in the future.

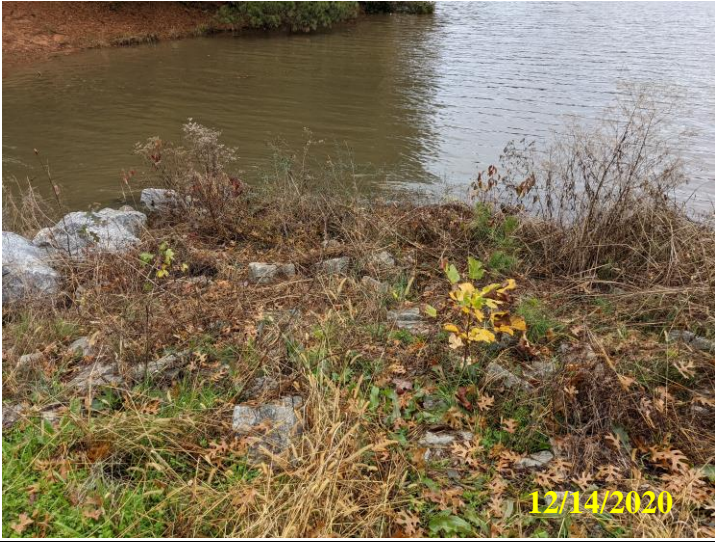
9. View of vegetation on upstream face of the dam

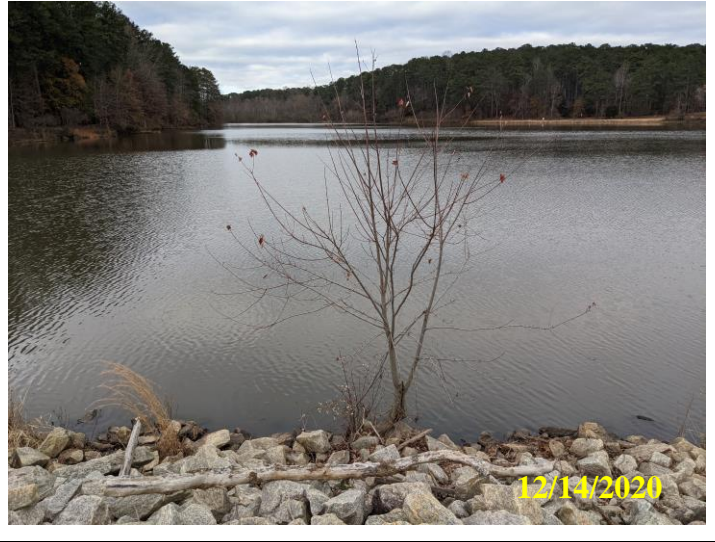
10. View of bare woody vegetation on upstream face of the dam

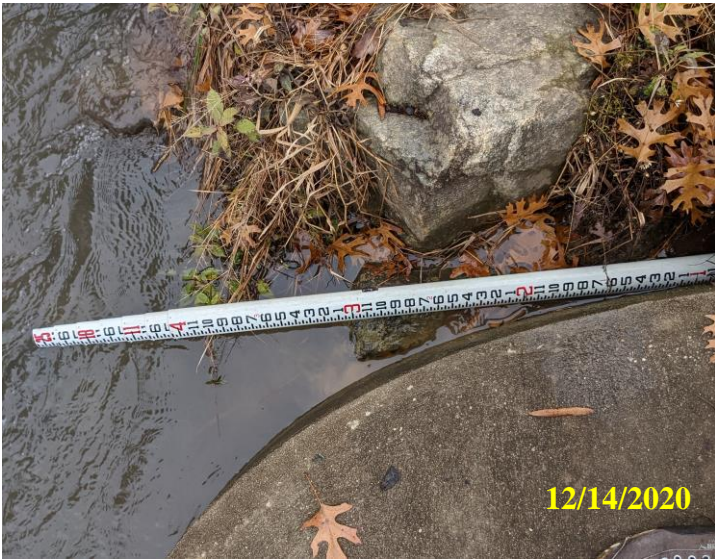
If yes, describe (size of area, location, severity, etc.)/Corrective Action: Significant erosion of the soil beneath the riprap was observed near the left wing wall of the concrete spillway. The erosion depth is up to 2-ft vertically in some locations immediately adjacent to the end of the left wing wall (See Photos 11- 13). There is both undercutting and erosion perpendicular to the wall. It appears that some of the riprap in this area has shifted slightly since previous inspections, though it is difficult to determine with certainty due to density of vegetation present in September's inspection. Future rain and high flow events can cause increased erosion and undercutting. Corrective actions are required and include filling and compacting the soil and placing a filter material and additional well-graded riprap to avoid further erosion near the concrete spillway. Repairs are necessary to prevent further erosion. Dense vegetation in this area remains despite the lower temperatures and should be cut back. There is insufficient riprap coverage in the area immediately adjacent to the right wing wall also, as noted in the previous inspection report from July 2020. (See Photo 30).

11. Inadequate riprap grading at the left wing wall of the concrete spillway resulting in erosion and undercutting of riprap. See Photo 12 for location of this photo

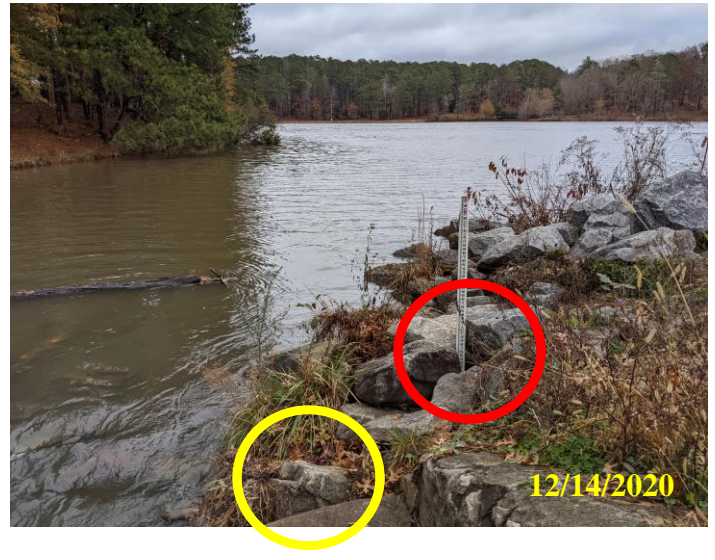
12. Inadequate riprap grading at the left wing wall of the concrete spillway resulting in erosion and undercutting of riprap, yellow circled area is location of Photo 11 and red circled area is location of 13

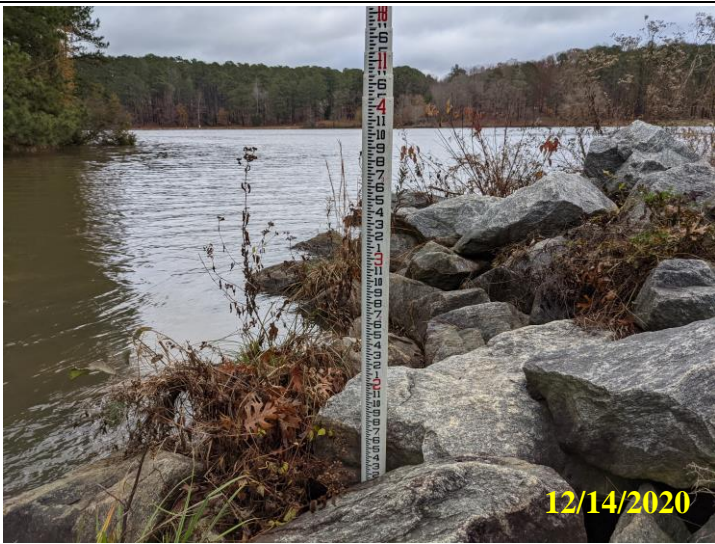
13. Inadequate riprap grading at the left wing wall of the concrete spillway resulting in erosion and undercutting of riprap

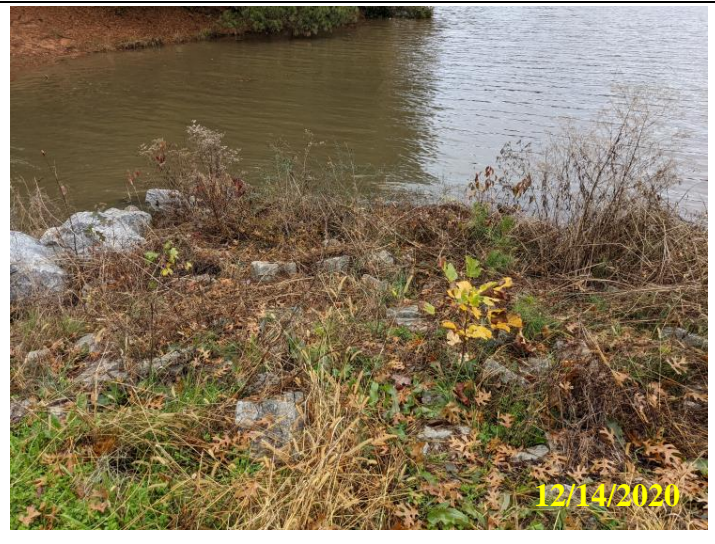
If yes, describe what type and its condition (for example, riprap - adequate, inadequate, sparse)/Corrective Action: Coverage of riprap is inconsistent across the width and height of the dam face (See Photo 14). The upper section of the dam face lacks adequate riprap coverage to provide protection at higher water levels. Recommend replacing riprap as needed across dam face to create uniform coverage up to sidewalk elevation. Notable areas include: 1) The right (west) side of the dam near the concrete spillway where it is visibly sparse compared to the rest of the dam face (See Photo 15), 2) Several makeshift pathways leading from the pedestrian walkway to the water near the upstream left abutment and near the principle spillway riser. (See Photo 16). Corrective action includes placing riprap along the dam face to create adequate uniform coverage of slope up to sidewalk elevation.

14. Sparse riprap near pedestrian walkway

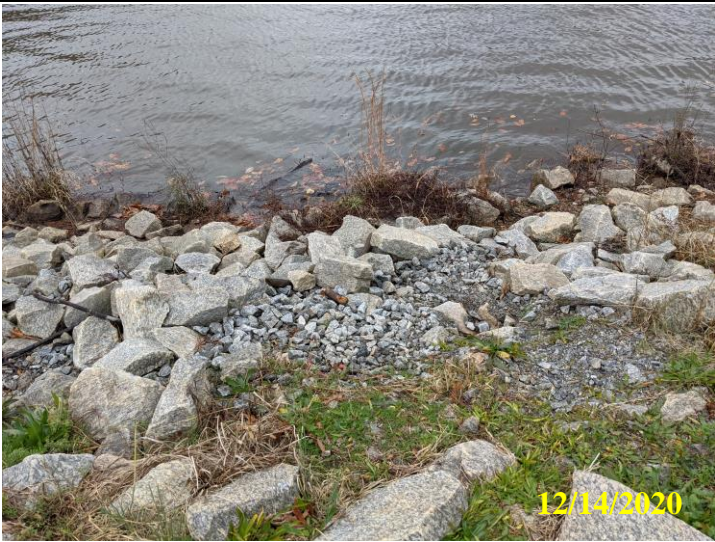
15. Sparse riprap coverage and uneven riprap sizing at right side of upstream dam face

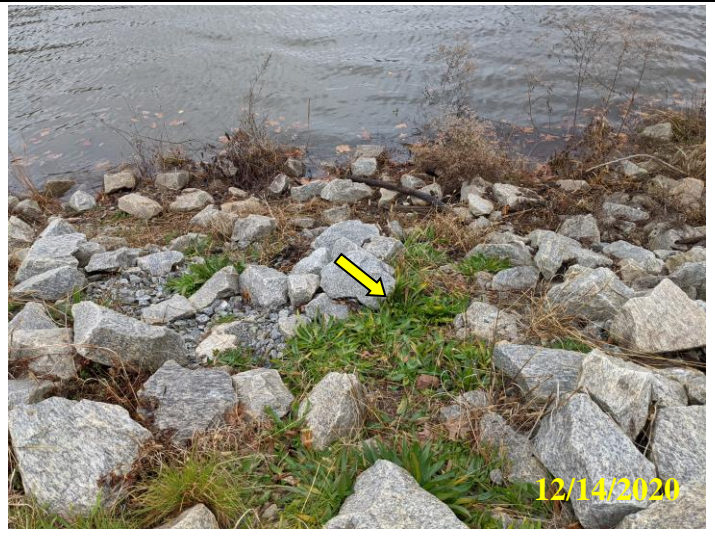
16. Pedestrian pathways showing sparse riprap near principal spillway riser

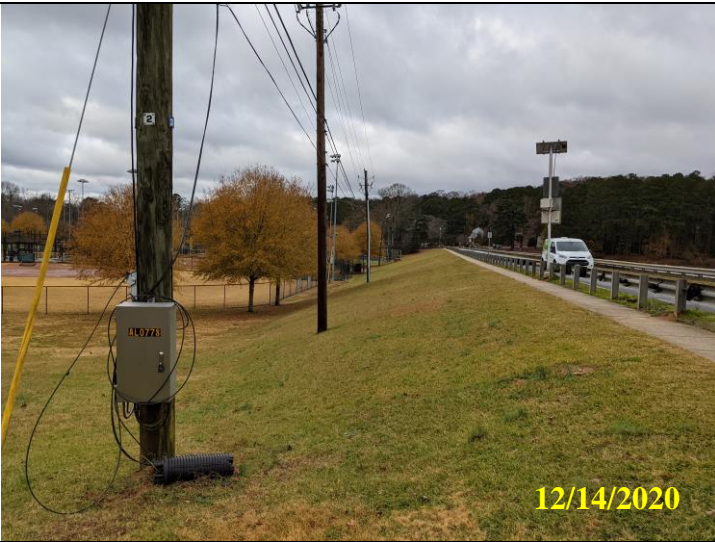
Other/Corrective Action (describe): The downstream slope of the dam is covered in well maintained recently mowed grass (See Photo 17 and 18). Several patches of missing grass on the right side of the downstream slope have exposed the underlying soil (See Photos 19 and 20). Recommend these areas be re-seeded and monitored to ensure that they don't grow larger or lead to increased erosion.

17. View of downstream slope looking toward right abutment

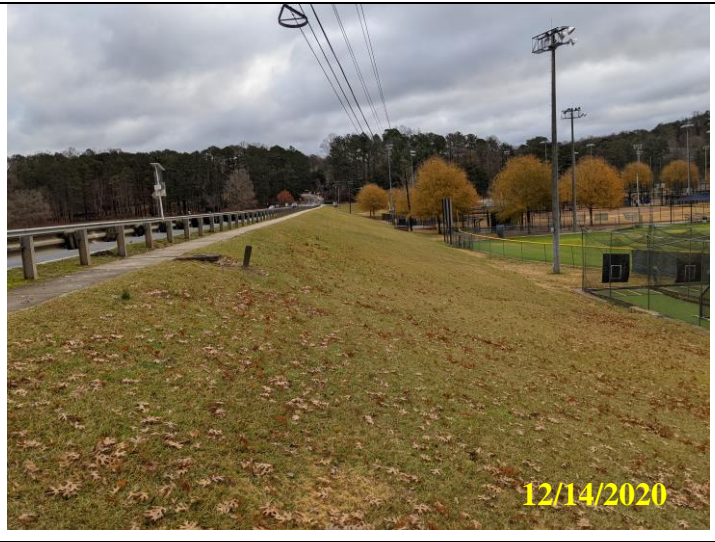
18. View of downstream slope looking toward left abutment

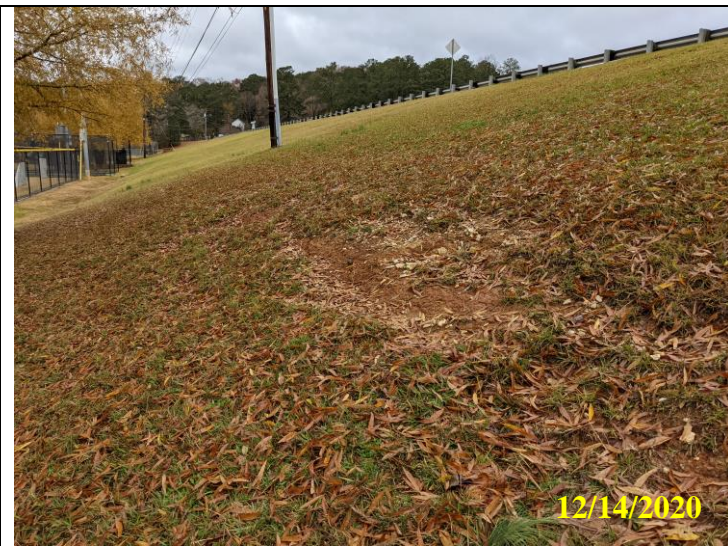
19. Patches of missing grass on downstream dam face

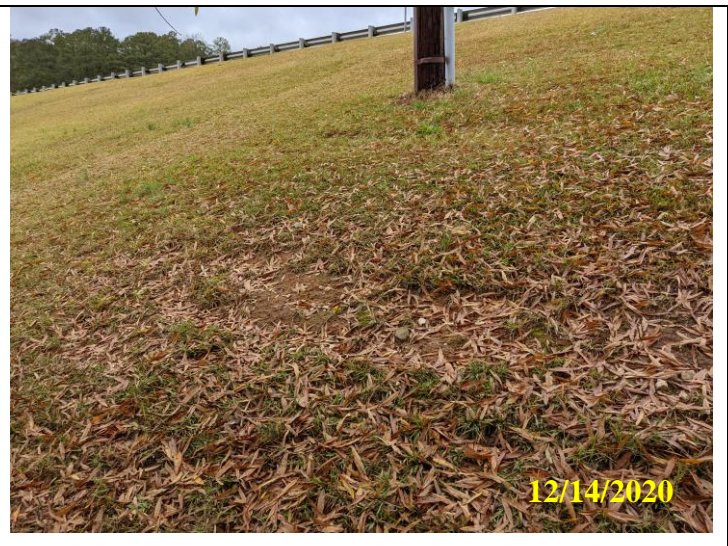
20. Patches of missing grass on downstream dam face

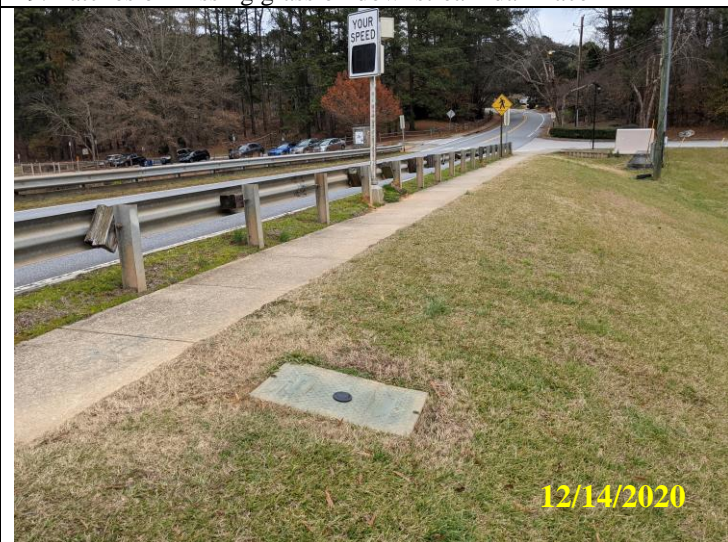
If yes, describe (size, location, etc.)/Corrective Action: The repairs to the damaged utility box adjacent to the electronic speed sign and surrounding soil appear to be holding up well with no signs of erosion. (See Photo 21).

21. Repaired utility box on downstream face of dam

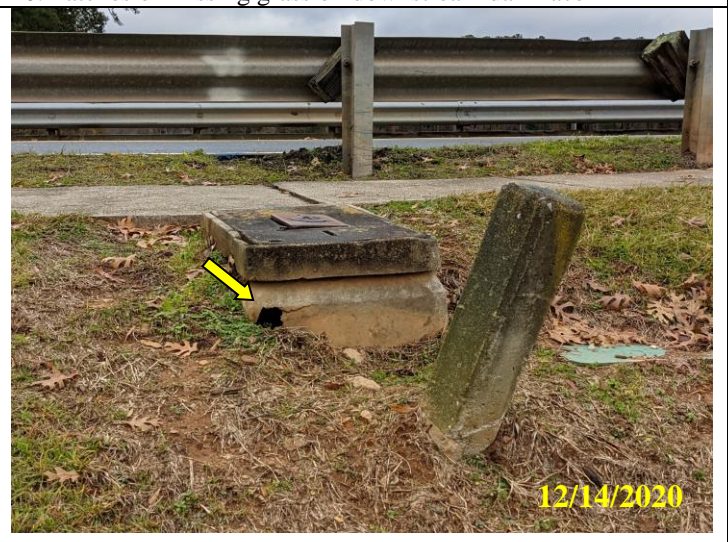
22. Damaged utility box on downstream face of dam

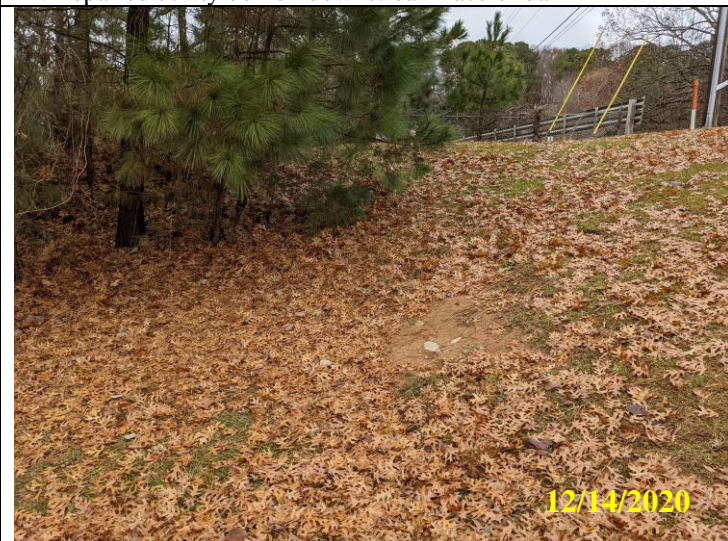
If yes, describe (size of area, location, severity, etc.)/Corrective Action: Minor erosion/bare spots were observed in high-traffic areas such as near the sprinkler box, the batting cages, principal spillway outlet box and near the right downstream abutment (See Photo 23). Corrective actions in these areas includes filling in bare spots, compacting and grassing or adding a layer of gravel if grass continues not to grow.

23. High traffic area at right side of downstream dam face showing erosion and missing grass

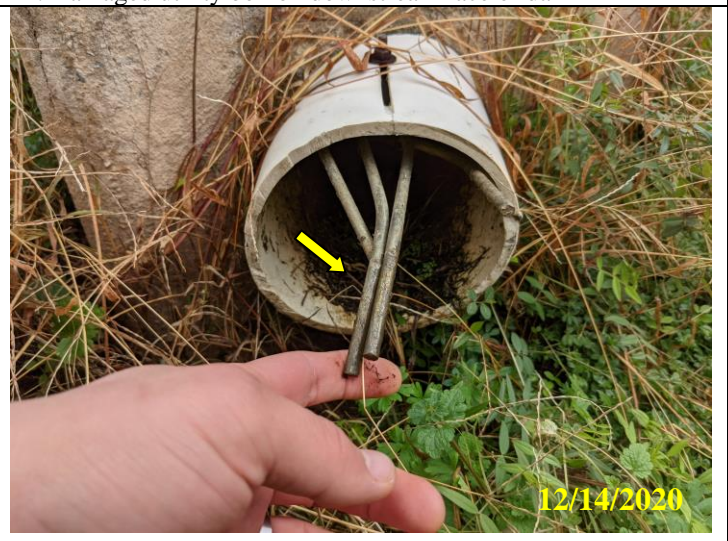
9. Other observations on the downstream slope/Corrective Action: An animal guard on the toe drain located roughly at center of downstream dam face should be straightened and secured from bottom to provide adequate barrier against small animals entering the drain pipe (See Photo 24). Previously noted minor damage to a utility box adjacent to a small concrete marker on the right side of the downstream face near the dam crest remains with no evidence of repair. (See Photo 22). A hole has formed in the fiberglass structure on the downstream side of the box. This hole should be repaired to ensure erosion does not occur around the utility box. Once repaired, the soil around the box should be backfilled and compacted to avoid any future erosion.

If yes, describe the condition (for example, clogged, free flowing, deteriorated, good condition) /Corrective Action: There is a toe drain near the center of the downstream slope (See Photo 24). There is no flow from the toe drain and it appears clear of large debris. Additionally, there are six spillway underdrains located on the spillway face above the plunge pool.

24. Toe drain at center of downstream dam face showing damaged animal guard.

If no, which drains lack animal guards? /Corrective Action: The damaged animal guard at the toe drain located near the center of the downstream slope observed in previous inspections has not been repaired (See Photo 24), it is recommended that the bars be straightened and secured at the bottom of the pipe to function effectively Animal guards are missing from three of the spillway underdrains on the right side of the spillway (See Photo 43). Corrective action includes replacing missing animal guards.

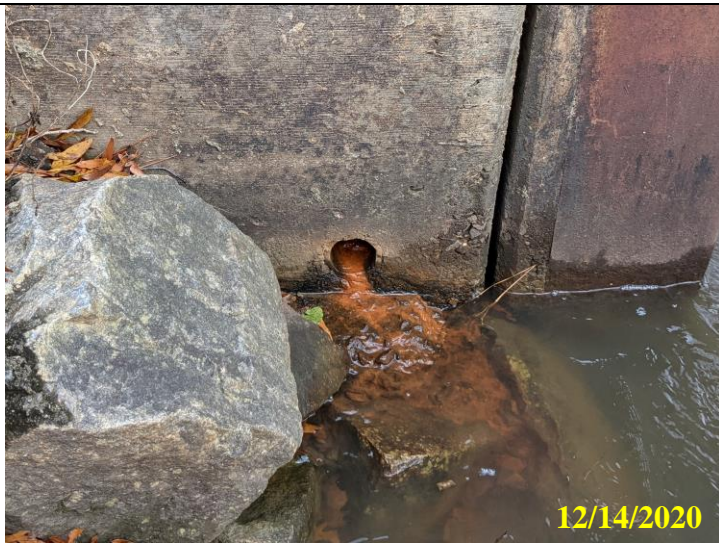
Minor flows were observed from some spillway underdrains but were not measured due to access (See Photo 43). A small toe drain at the right side of the plunge pool was observed to be emitting a rust colored liquid (See Photo 25). This may be evidence of rusted or otherwise compromised pipes, possibly related to the potential void behind the face of the plunge pool wall.

25. Toe drain at right side of plunge pool discharging rust colored liquid

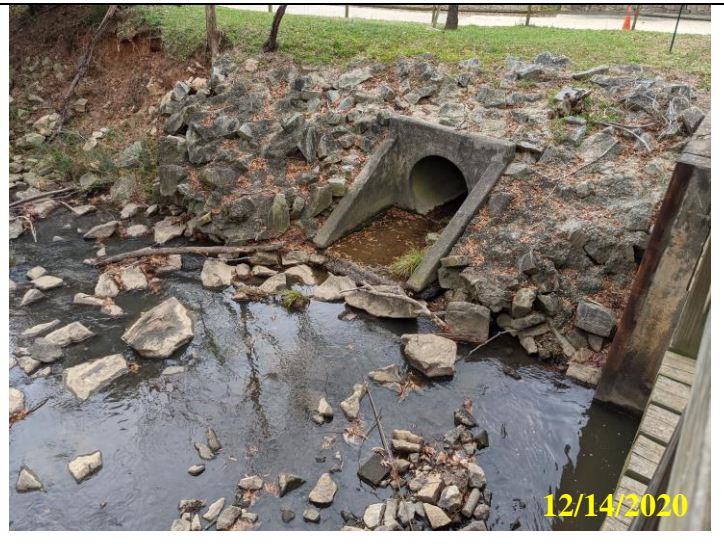
1). Erosion is observed at the right stream bank downstream of the plunge pool immediately next to the storm drain headwall (See Photo 26). This erosion does not appear to have worsened since the September inspection. Although it is not impacting the dam's safety, it is recommended to stabilize the stream bank and place additional riprap to protect the bank

26. Erosion and undercutting observed near storm drain headwall downstream of plunge pool

and prevent further undercutting around the headwall. The inspection report from December 2018 notes that the City was in the process of procuring a consultant to address this, though no evidence of corrective action has since been observed.

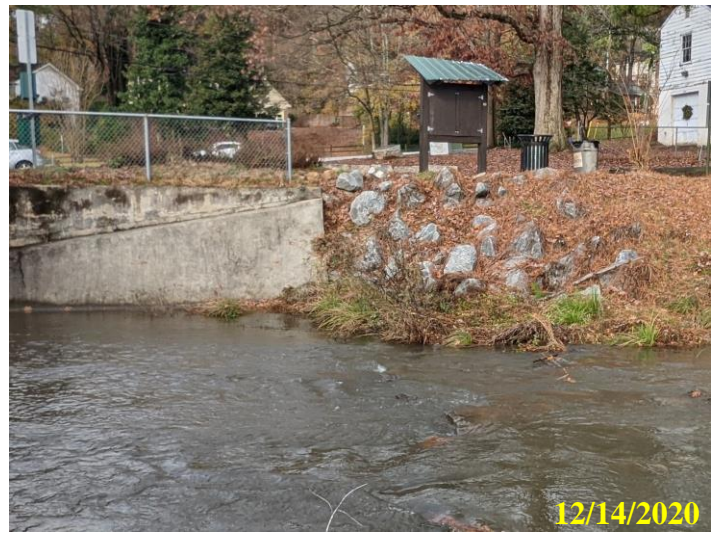
30. Vegetation and silt obstructing right side of upstream spillway. Sparse riprap along the right wing wall of the spillway

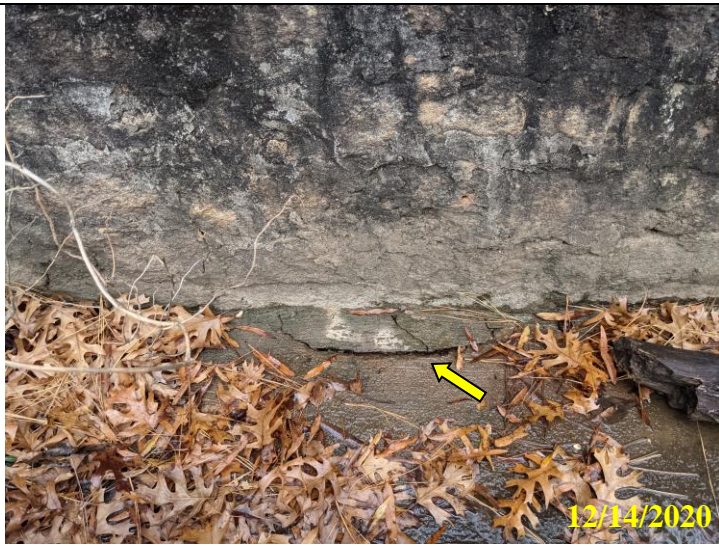
If yes, describe (width of crack or hole, location, etc.)/Corrective Action: The cutoff wall at the upstream face of the concrete spillway appeared to be in good condition and functioning well. There are multiple areas of uplifting concrete at the joint of the spillway and the masonry wall on the left side of the flume downstream of West Nancy Creek Drive (See Photos 31- 33). Corrective action includes sealing the cracks to prevent widening or lengthening. Concrete is completely separated from one of these locations, leaving a hole 2 to 3 inches deep at the masonry wall joint (See Photo 33). Corrective action includes grouting and patching holes left behind by chipped or concrete spalls. 2) The caulk in the joints between the spillway bottom and the retaining walls along the left side of the spillway is missing or eroded over the majority of the spillway length (See Photo 32). Corrective action includes removing old caulk and reapplying caulk to the joints between the spillway base and the retaining walls of the spillway along its entire length. 3) Along the masonry retaining wall at the left side of the concrete spillway, there are cracks and areas missing grout between many of the stones. Vines and other vegetation previously observed growing on the masonry wall appears to have died back due to low temperatures but may return in warmer months (See Photos 36- 39). Corrective action includes removing any vegetation and re-grouting impacted areas. The prescribed repairs should be considered a provisional solution and the aging masonry wall should eventually be replaced with a concrete wall. 4) Caulk between concrete slabs making up the spillway bottom is peeling and working loose from the lateral seams in multiple locations. The lateral seam directly upstream of the West Nancy Creek Drive bridge was observed to be undermined and a cavity roughly 6 inches deep directly under the joint was observed. As noted in previous reports, caulk is also peeling from the lateral seam downstream of the bridge. (See Photos 40 and 41). Corrective action includes removing old caulk and replacing with new caulk. 4) Some of the trees and vegetation growing along the fence line on both sides of the spillway were previously cut back (See Photos 42). . . Previously noted regrowth has halted due to lower temperatures but is likely to continue in warmer months. Corrective action includes cutting/removing trees/vegetation including the remaining lower trunks of cut trees to prevent new growth. Any holes must be filled and compacted. It is recommended that any trees within 15 feet of the spillway walls be removed. Grass previously observed growing between lateral seams in the spillway slabs has died back in the colder weather but will likely return in warmer months (See Photo 35). All grassy vegetation should be cleared from the spillway channel and joints resealed. Previously completed repairs to spillway slab adjacent to concrete wall appear to be holding up well (See Photo 34). The right wing wall downstream of the plunge pool is showing beginnings of minor erosion at the top edges (See Photos 44-45). This area should be backfilled and compacted and monitored to ensure the erosion does not worsen.

31. Concrete spillway cracking and uplift at masonry wall joint

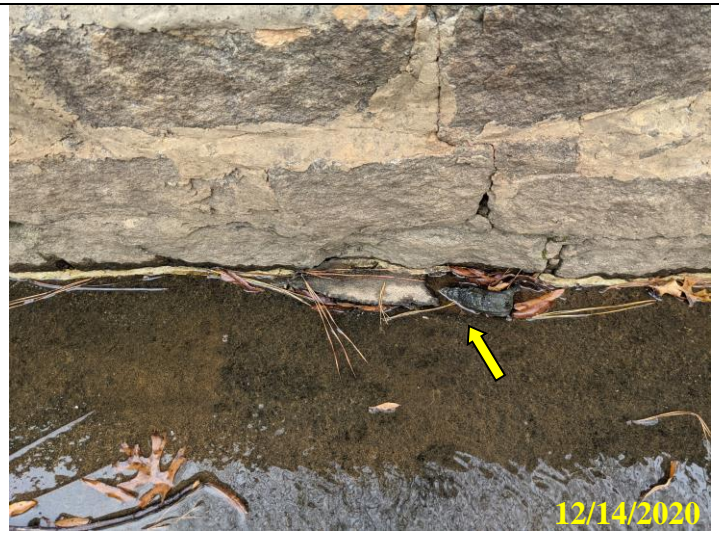
32. Concrete spillway cracking and uplift at masonry wall joint with exposed seal

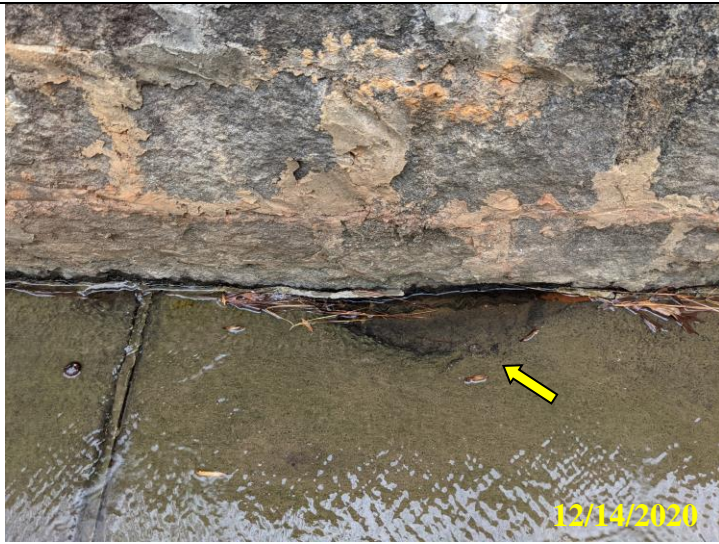
33. Concrete spillway cracking and spalling concrete at masonry wall joint

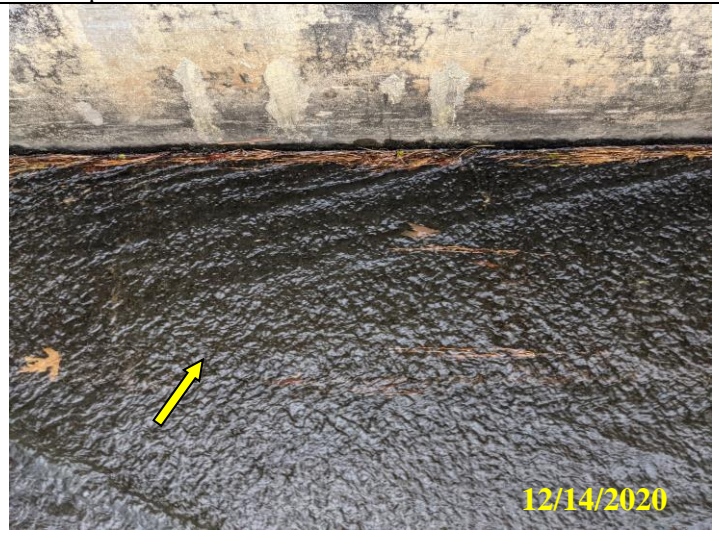
34. Previously completed repairs to spillway functioning well

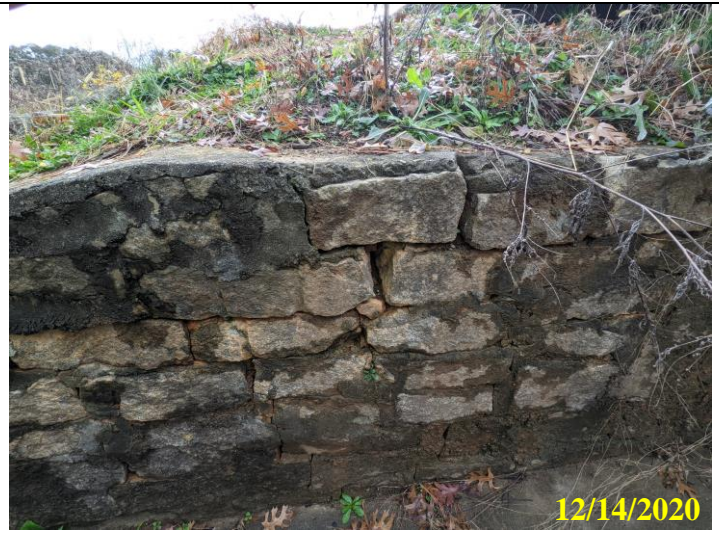
36. Missing grout and cracks in masonry wall at spillway entrance

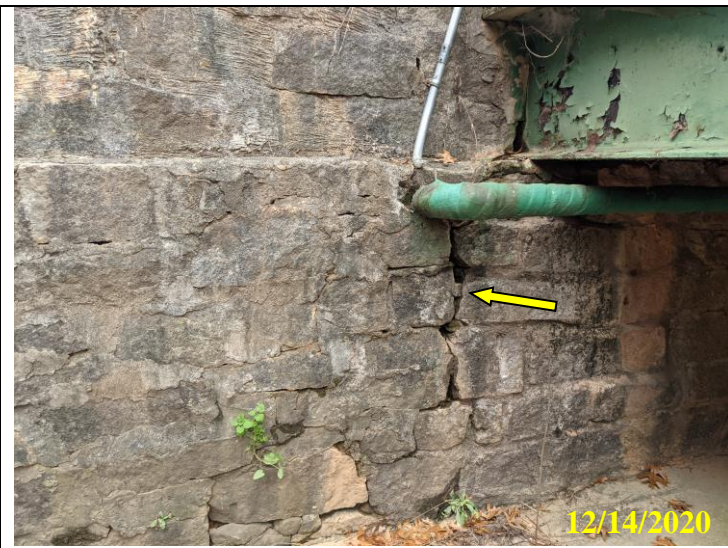
37. Missing grout in masonry wall at bridge crossing

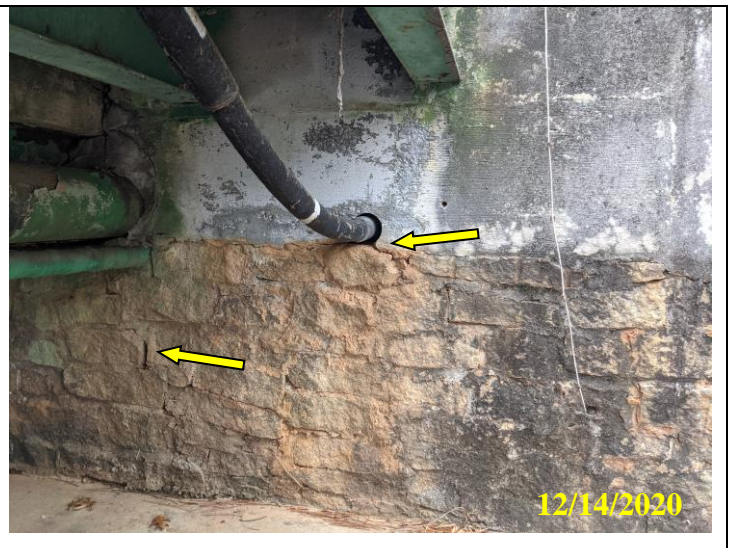
38. Missing grout in masonry wall at bridge crossing

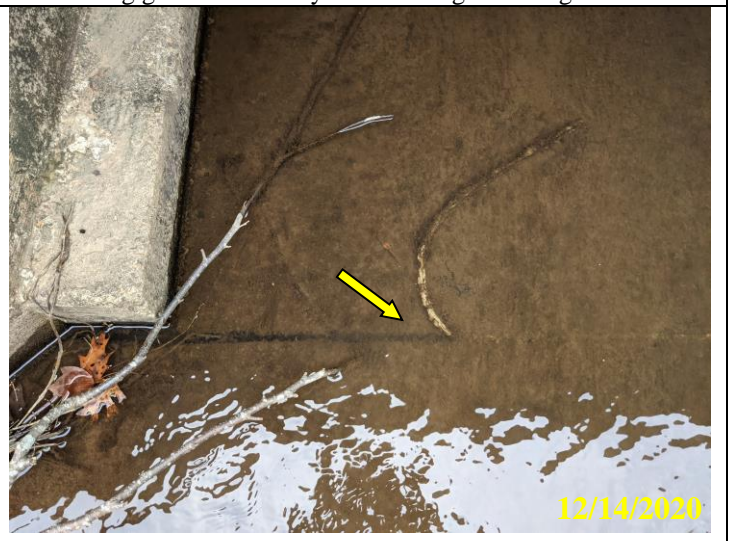
40. Caulking peeling from between spillway slabs at bridge crossing

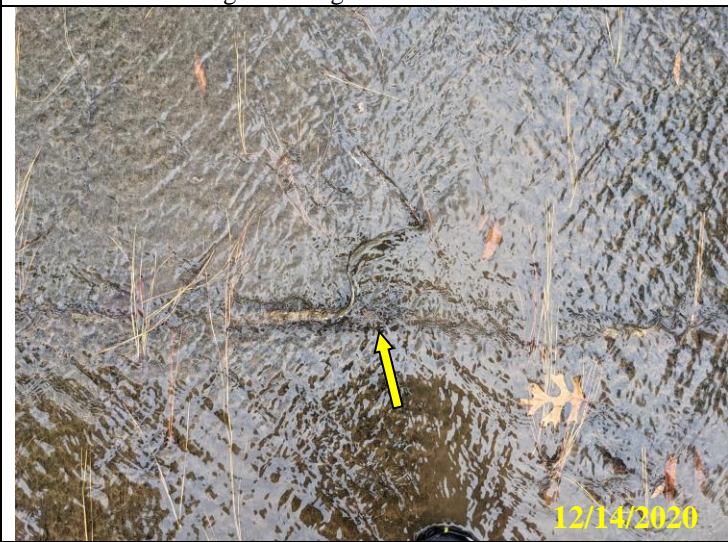
41. Caulk peeling from between spillway slabs downstream of bridge crossing

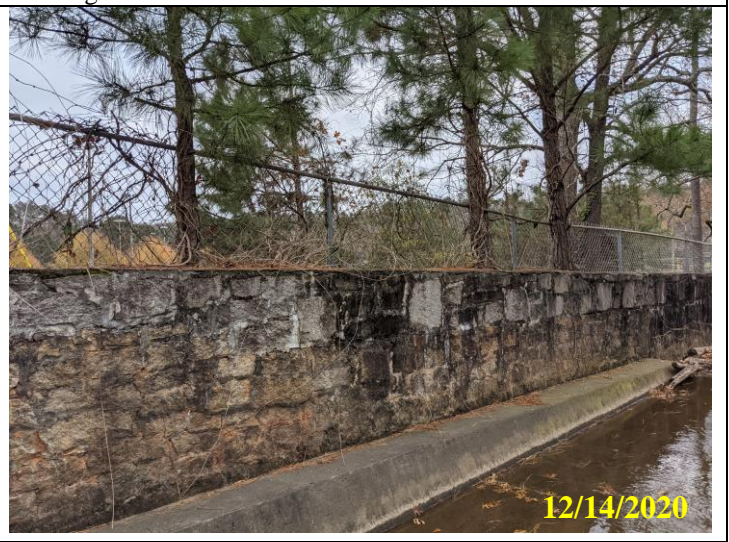
42. Trees at spillway fence

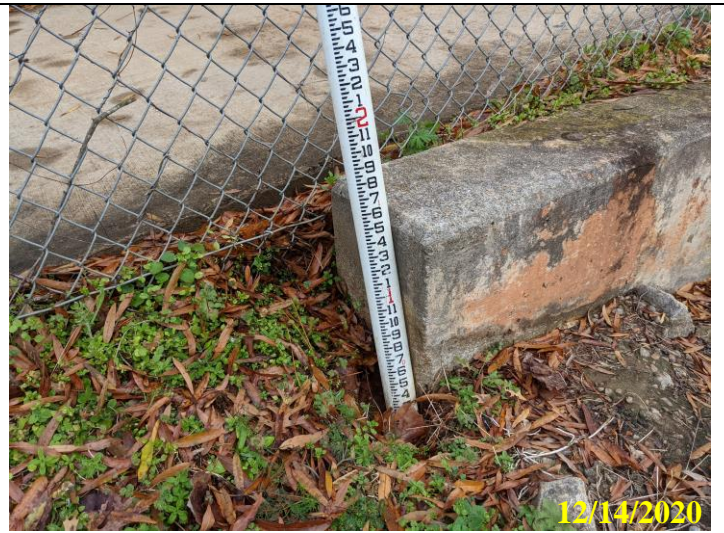
44. Minor undercutting and erosion at the end of the concrete spillway wall. See Photo 45 for location
