Quarterly Dam Inspection Report

Murphey Candler Park Dam, City of Brookhaven

April 26, 2022

Dewberry

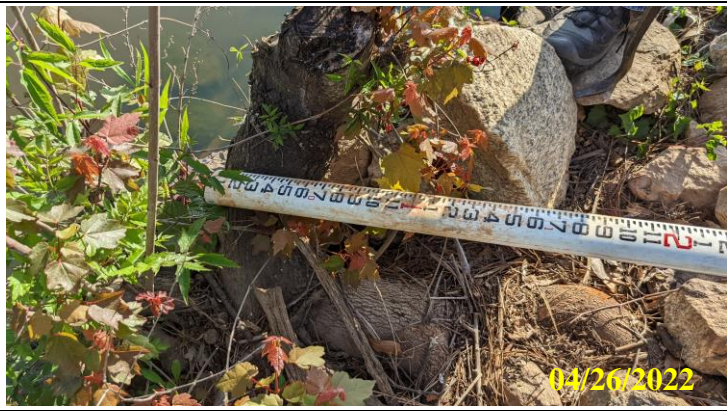
9. View of stump close to diameter requiring engineer oversight for removal, located on right side of upstream dam face at waterline

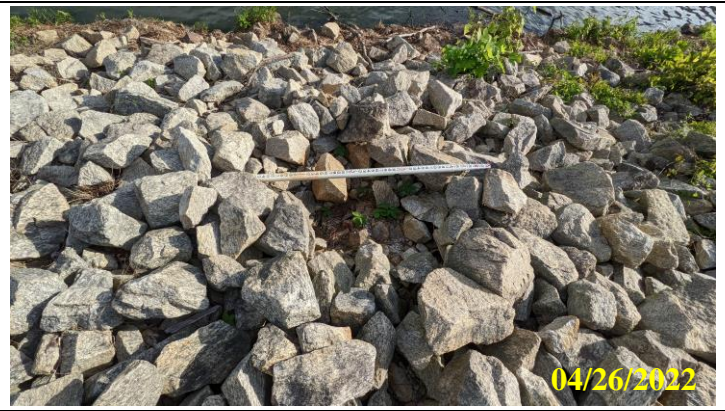
10. View of disturbed riprap around cut back woody vegetation on upstream face of the dam

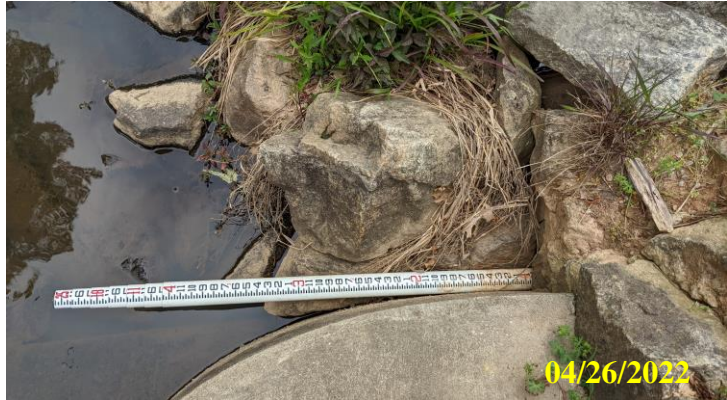
If yes, describe (size of area, location, severity, etc.)/Corrective Action: Significant erosion of the soil beneath the riprap continues to progress near the left wing wall of the concrete spillway. The erosion depth is up to 2-ft vertically in some locations immediately adjacent to the end of the left wing wall, comparison with previous inspection photos shows that 6 inches of soil have eroded since the December 2020 inspection in one location. (See Photos 11- 13). There is both undercutting and erosion perpendicular to the wall. Horizontal undercutting adjacent to the wing wall seen in Photo 11 has removed soil up to one foot under the wingwall. Future rain and high flow events can cause increased erosion and undercutting. Corrective actions are required and include filling and compacting the soil near the concrete spillway. Repairs are necessary to prevent further erosion. There is insufficient riprap coverage in the area immediately adjacent to the right wing wall also, as noted in previous inspection reports (See Photos 27 and 30). Soil has started to erode from beneath the sidewalk on the upstream side of the dam crest as well, leaving a void several inches beneath the sidewalk in some places. (See Photo 21). Recommend backfilling soil in the void beneath the sidewalk and placing a filter material and additional well-graded riprap to prevent continued erosion.

11. Inadequate riprap grading at the left wing wall of the concrete spillway resulting in erosion and undercutting of riprap. See Photo 12 for location of this photo.

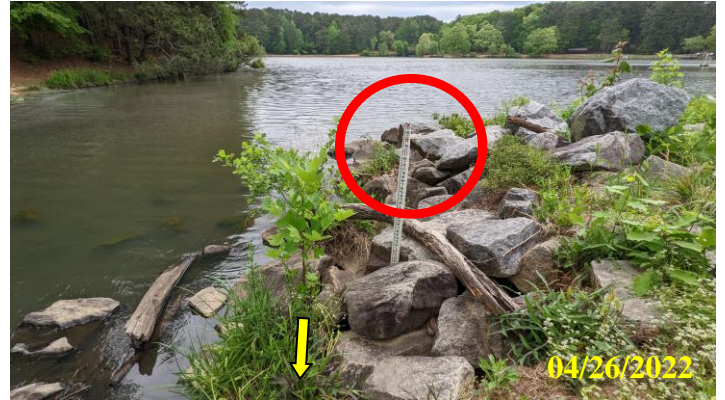
12. Inadequate riprap grading at the left wing wall of the concrete spillway resulting in erosion and undercutting of riprap. Red circled area is location of Photo 13, yellow arrow pointing towards location of Photo 11

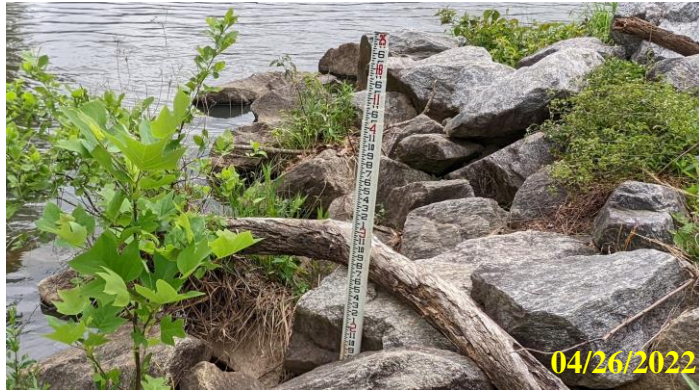
13. Inadequate riprap grading at the left wing wall of the concrete spillway resulting in erosion and undercutting of riprap

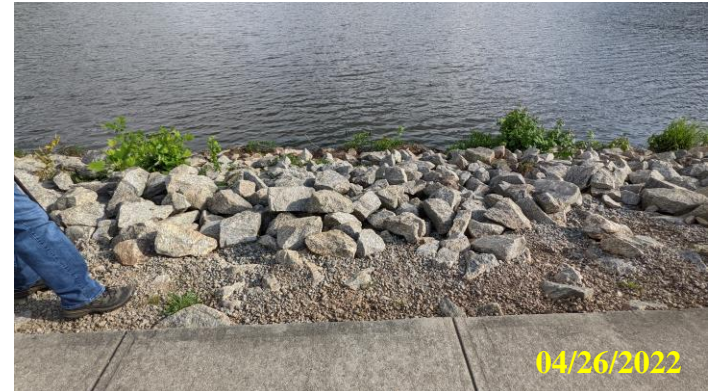
If yes, describe what type and its condition (for example, riprap - adequate, inadequate, sparse)/Corrective Action: Coverage of riprap is inconsistent across the width and height of the dam face (See Photos 6, 9, 14-16). Inconsistent coverage at lower elevations leaves opportunity for concentrated flows and subsequent erosion. Similarly, the upper section of the dam face lacks adequate riprap coverage to provide protection at higher water levels. Recommend replacing riprap as needed across dam face to create uniform coverage up to sidewalk elevation. Notable areas include: 1) The right (west) side of the dam near the concrete spillway where it is visibly very sparse compared to the rest of the dam face (See Photo 15). 2) Several makeshift pathways leading from the pedestrian walkway to the water near the upstream left abutment and near the principle spillway riser (See Photo 16). As Discussed in item 5 above, potential consequences of insufficient riprap coverage include providing opportunities for concentrated flows of water, leading to channelization and erosion of the dam slope. Corrective action includes placing a filter material and well-graded riprap along the dam face to create adequate uniform coverage of the slope up to the sidewalk elevation.

14. Sparse riprap near pedestrian walkway

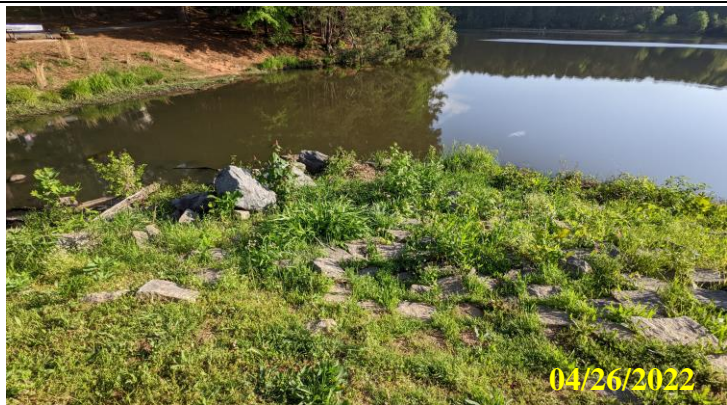
15. Very sparse riprap coverage at right side of upstream dam face

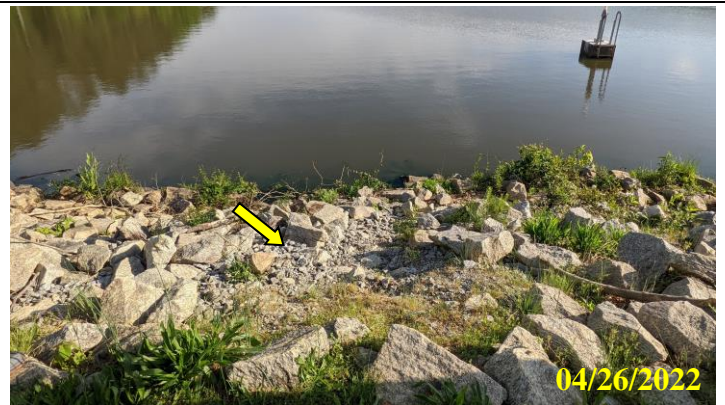
16. Pedestrian pathway showing sparse riprap near principal spillway riser

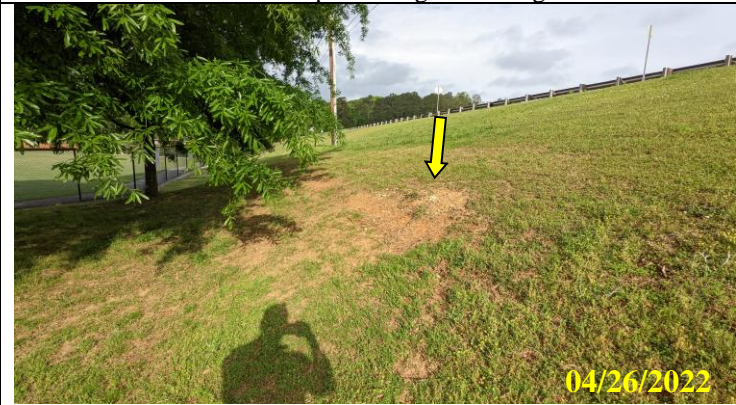
Other/Corrective Action (describe): The downstream slope of the dam is covered in well maintained recently mowed grass (See Photo 17 and 18). Several patches of missing grass on the left side of the downstream slope have exposed the underlying soil (See Photos 19, and 20). Recommend these areas be re-seeded and monitored to ensure that they don't grow larger or lead to increased erosion. There is a large area of soil exposed by equipment used to place riprap around the batting cages on the right side of the downstream slope, to the left of the spillway (See Photo 23). This area should be seeded with grass or otherwise stabilized to prevent soil erosion.

19. Patches of missing grass on downstream dam face

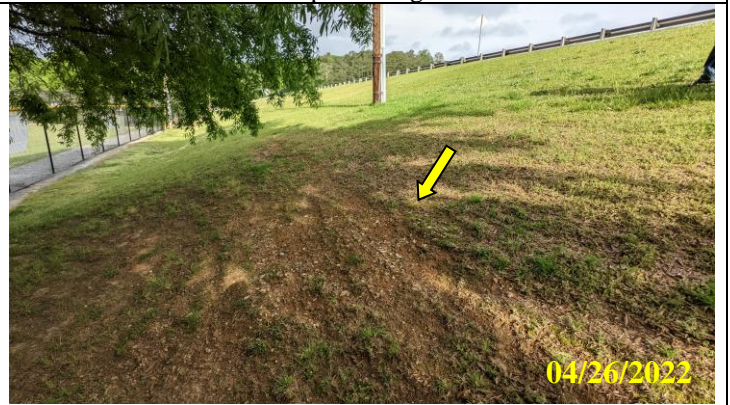
20. Patches of missing grass on downstream dam face

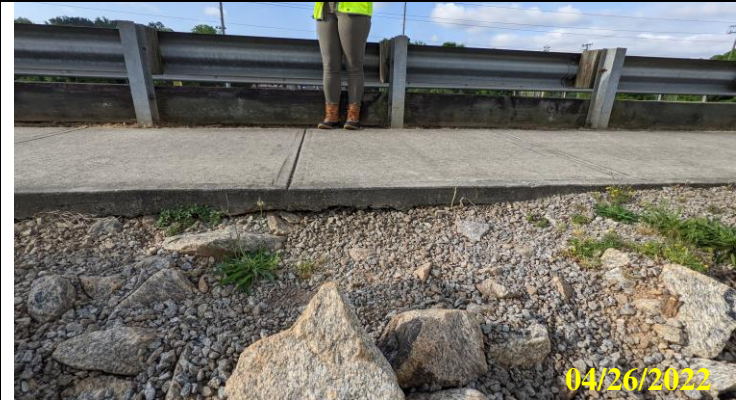
21. Minor undercutting and erosion at the pedestrian walkway on upstream dam crest

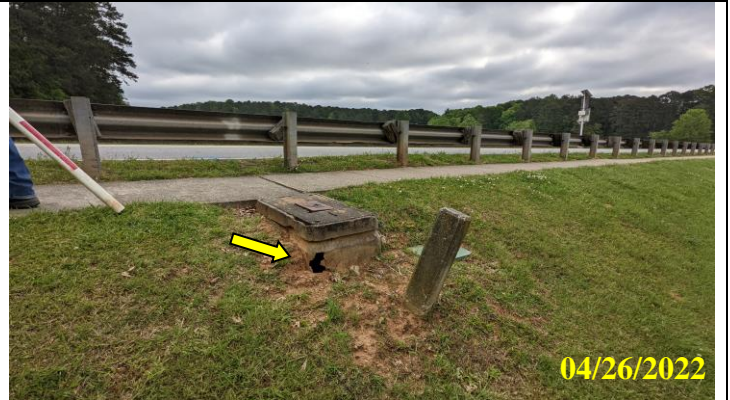
22. Damaged utility box and eroded soil on downstream face of dam

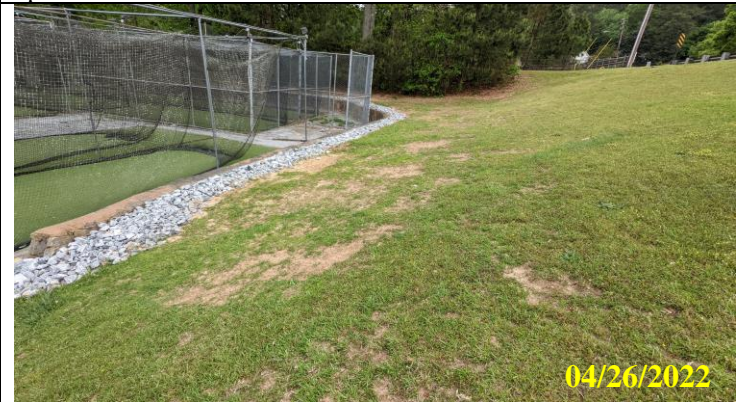
23. Right side of downstream dam face showing erosion and missing grass from equipment traffic

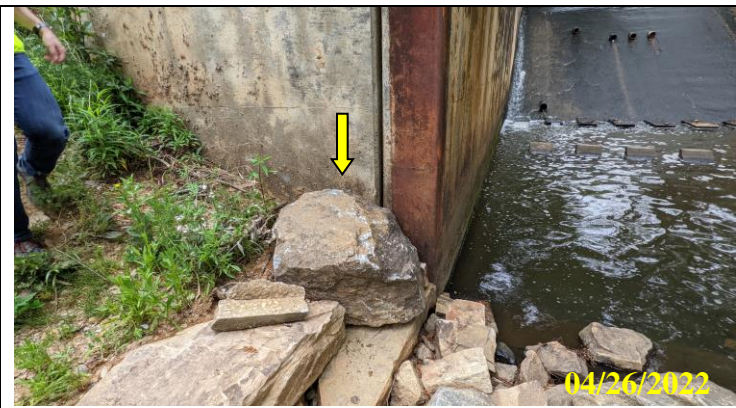
25. Toe drain at right side of plunge pool blocked by riprap

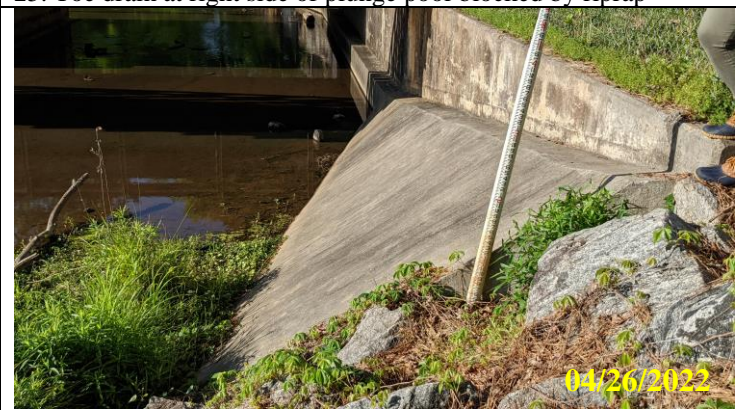
27. View of overgrown vegetation and sparse poorly graded riprap at the right upstream wingwall

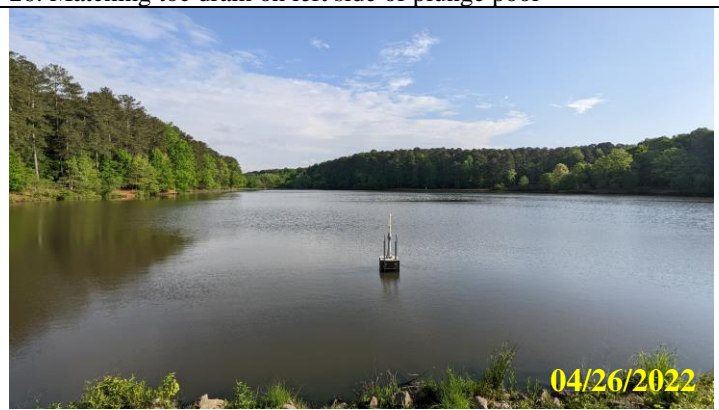
If yes, describe (type of debris, reason for obstruction, etc.) /Corrective Action: On 6/21/2017, DeKalb County Fire & Rescue divers inspected the principal upstream riser structure (See Photo 28). The divers did not identify any issues in the outer part of the riser or sluice gate. They did note that the orifice was buried in soft silt. An inspection has not been performed since. Wasps have built a nest inside the riser tube. The wasp nest should be removed to avoid potential hazards during any maintenance or emergency operation of the spillway riser.

28. Principal spillway riser

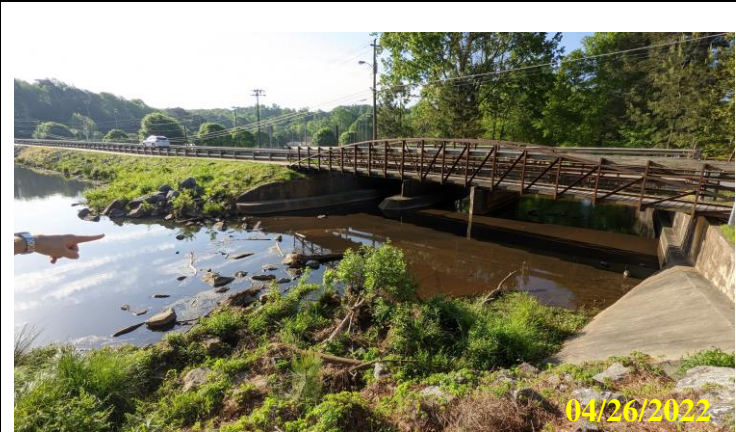
8. For concrete or earth channel spillways, is the entrance or channel obstructed in any way? Yes No _____
- If yes, describe (type of obstruction, location, etc.)/Corrective Action: A small amount of woody debris has collected at the upstream end of the spillway platform (See Photo 29). This debris should continue to be removed as it collects. The mat of grassy vegetation growing from the right bank into the concrete spillway was previously cleared. It remains much improved from the previous overgrown state, but the location should be monitored for vegetation and silt collecting again. (See Photo 30). Grass should be periodically cut back and removed as it grows back to prevent increased accumulation of sediment and debris in the spillway. Grass between spillway slabs was dormant in the previous inspection but has resumed growing again. Concrete joints upstream and downstream of the West Nancy Creek Drive bridge also needs to be resealed, as noted in section 12 below (See Photos 35, and 40).

29. Small amounts of woody debris accumulating in the upstream section of concrete spillway

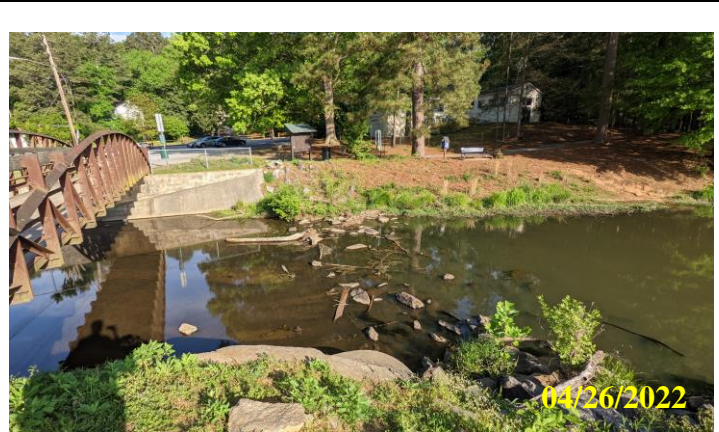
30. Cleared vegetation from right side of spillway, sparse riprap along the right wing wall

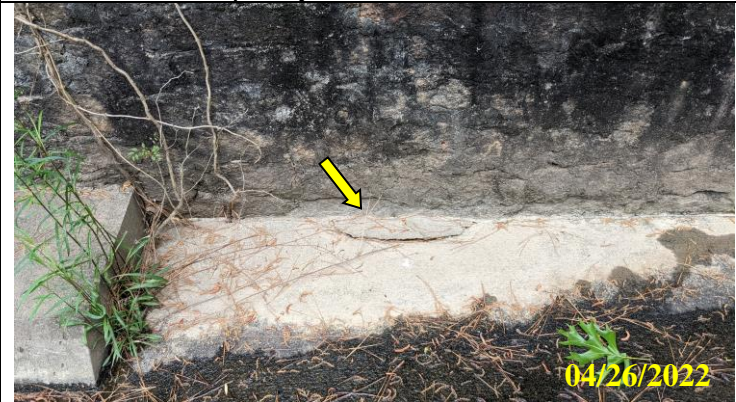
- If yes, describe (width of crack or hole, location, etc.)/Corrective Action: The cutoff wall at the upstream face of the concrete spillway appeared to be in good condition and functioning well. 1) There are multiple areas of uplifting concrete at the joint of the spillway and the masonry wall on the left side of the flume, downstream of West Nancy Creek Drive (See Photos 31- 33). Corrective action includes sealing the cracks to prevent widening or lengthening. Concrete is completely separated from one of these locations, leaving a hole 2 to 3 inches deep at the masonry wall joint (See Photo 33). Corrective action includes grouting and patching holes left behind by chipped or spalling concrete. 2) The caulk in the joints between the spillway bottom and the retaining walls along the left side of the spillway is missing or eroded over the majority of the spillway length (See Photo 32). Corrective action includes removing old caulk and reapplying caulk to the joints between the spillway base and the retaining walls of the spillway along its entire length. 3) Along the masonry retaining wall at the left side of the concrete spillway, there are cracks and areas missing grout between many of the stones (See Photo 36-39). Vines and other vegetation previously observed growing on the masonry wall directly downstream of West Nancy Creek Drive have begun growing again in warmer temperatures. (See Photo 39). Corrective action includes removing any remaining vegetation and re-grouting impacted areas. The prescribed repairs should be considered a provisional solution, and the aging masonry wall should eventually be replaced with a concrete wall. 4) Caulk between concrete slabs making up the spillway bottom is peeling and working loose from the lateral seams in multiple locations. The lateral seam directly upstream of the West Nancy Creek Drive bridge was observed to be undermined, and a cavity roughly 6 inches deep directly under the joint was observed. As noted in previous reports, caulk is also peeling from the lateral seam downstream of the bridge (See Photos 40 and 41). Corrective action includes removing old caulk and replacing with new caulk. 4) Concrete has completely separated from the bottom of a vertical crack at the top right of the plunge pool face (See Photo 44). This area of the spillway sees continuous flows, and the cracked concrete is a potential entry point for water to erode soil beneath the spillway. Corrective action includes sealing the cracks to prevent widening or lengthening. 5) Some of the trees and vegetation growing along the fence line on both sides of the spillway were

31. Concrete spillway cracking and uplift at joint with masonry wall

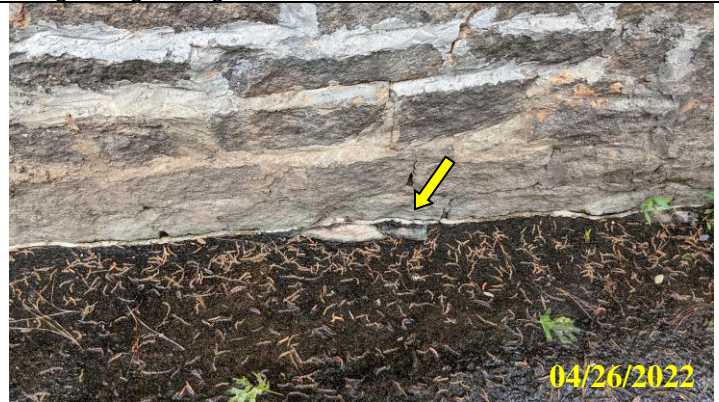
32. Concrete spillway cracking and uplift at masonry wall joint with exposed seal

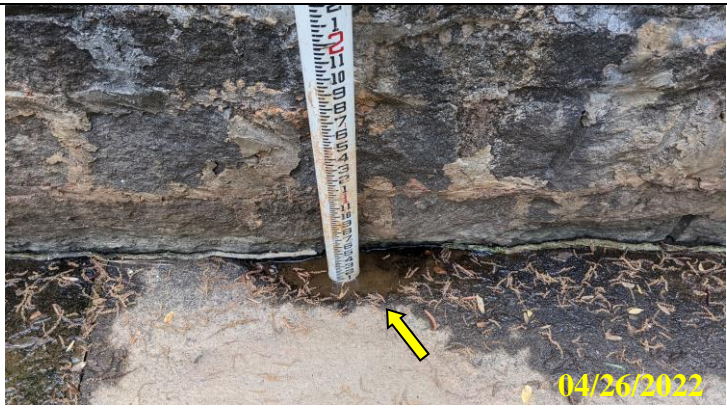
33. Concrete spillway cracking and missing concrete at masonry wall joint

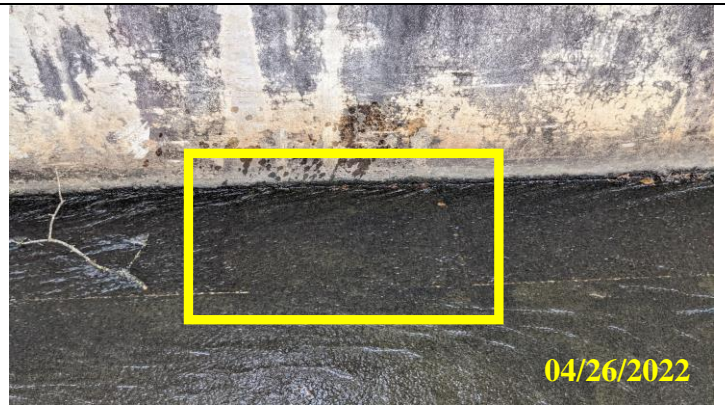
34. Previously completed repairs to spillway holding up well

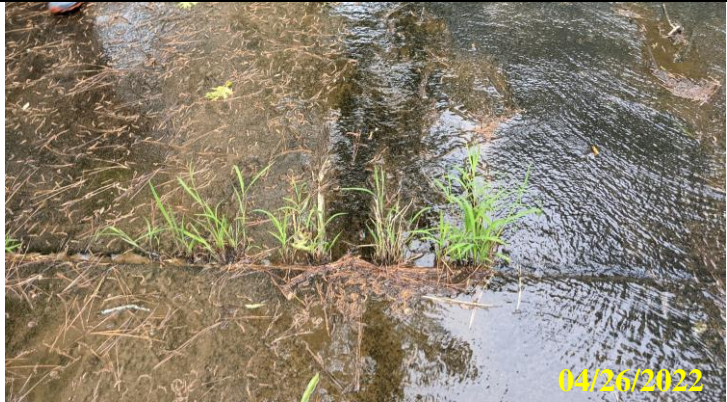
35. Grass growing between slabs in concrete spillway downstream of West Nancy Creek Drive

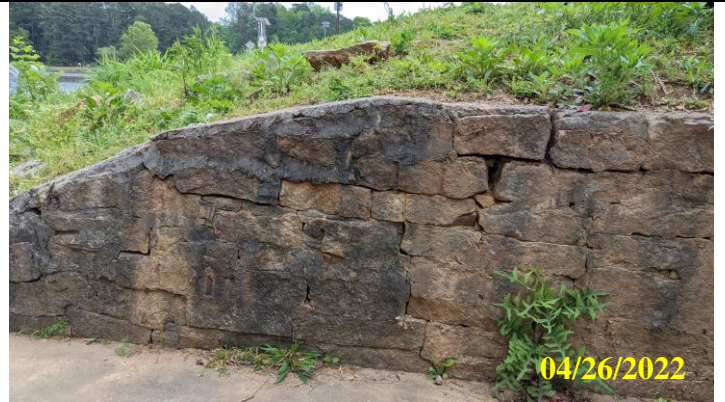
36. Missing grout and cracks in masonry wall at spillway entrance

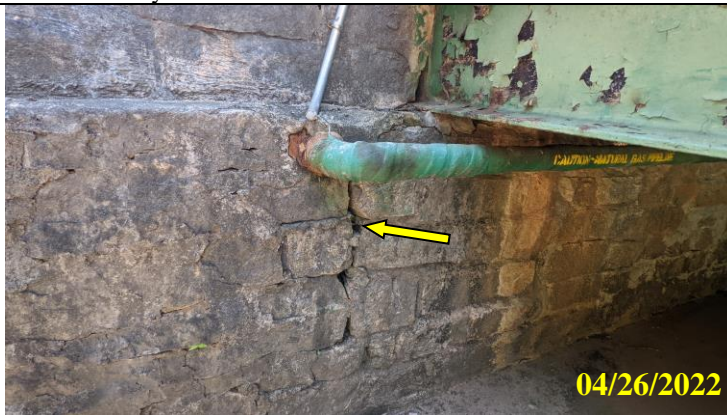
37. Missing grout in masonry wall at bridge crossing

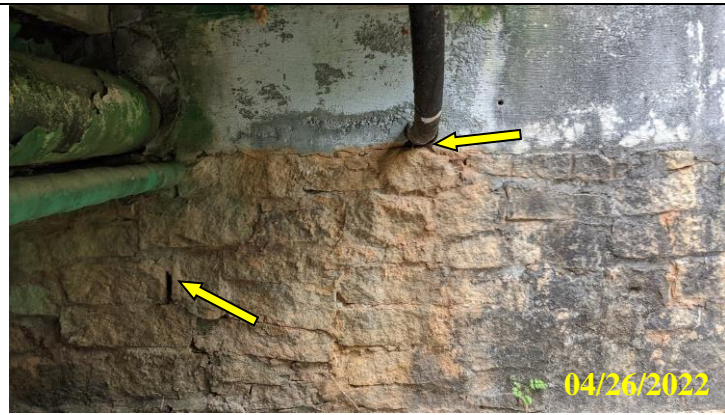
38. Missing grout in masonry wall at bridge crossing

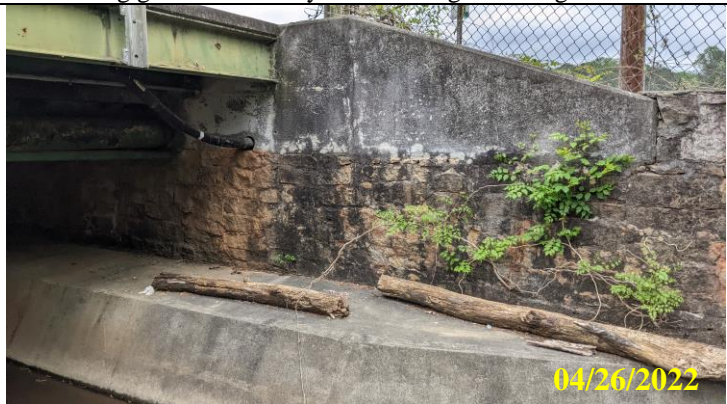
39. Vines and vegetation beginning to regrow on masonry wall downstream of bridge crossing

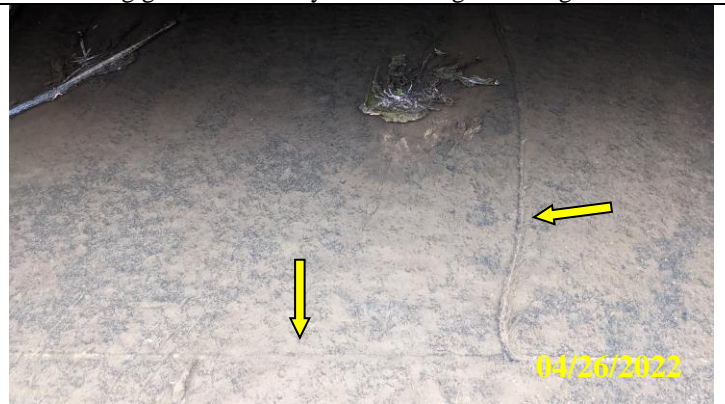
40. Caulking peeling from between spillway slabs at upstream edge of bridge crossing, 6 inch void between slabs

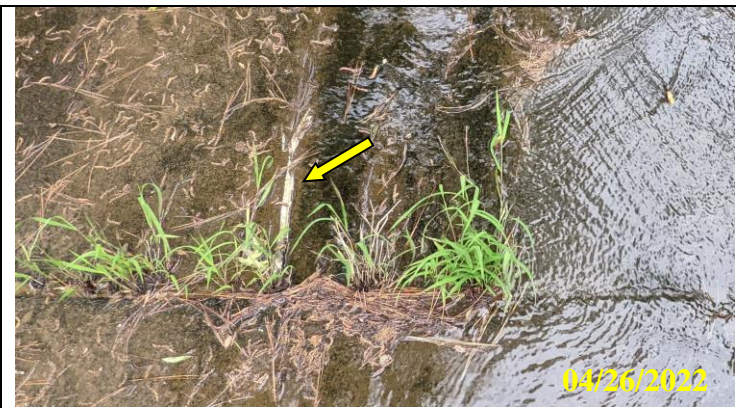
41. Caulk peeling from between spillway slabs downstream of bridge crossing

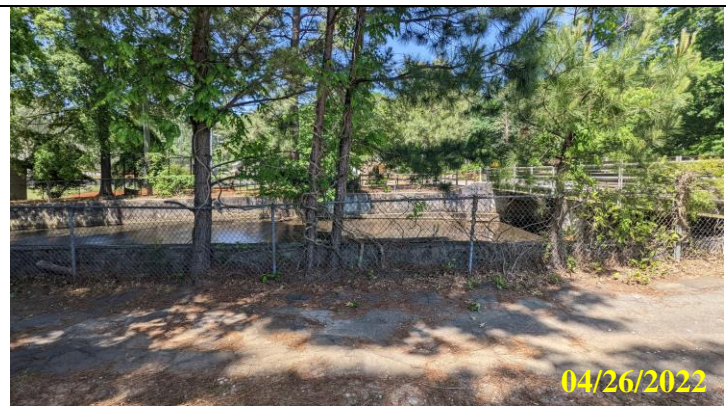
42. Trees at spillway fence, growing directly adjacent to and touching masonry wall

previously cut back but have begun growing again (See Photo 42). Corrective action includes cutting/removing trees/vegetation including the remaining lower trunks of cut trees to prevent new growth. Any holes must be filled and compacted. It is recommended that any trees within 15 feet of the spillway walls be removed. Grass previously dormant in colder temperatures during the Jan 2022 inspection has resumed growing (See Photo 35). All grassy vegetation should be cleared from the spillway channel and joints resealed. Previously completed repairs to spillway slab adjacent to concrete wall appear to be holding up well (See Photo 34).

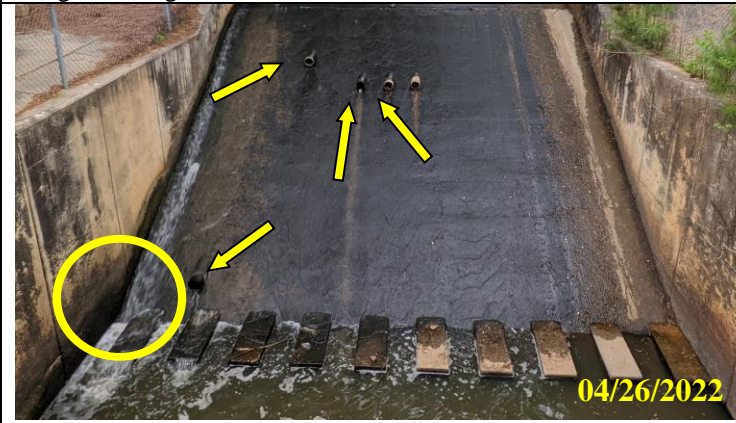
If yes, describe (size of area, location, severity, etc.) /Corrective Action: There is potentially a cavity forming beneath the lower right (west) face of the spillway directly above the plunge pool (See Photo 43). During the December 2019 and October 2021 inspections, striking the face of the spillway with a survey rod produced a hollow tone in this location, distinct from solid sounds produced by striking elsewhere on the spillway. There is no readily apparent cause of the cavity. Further investigation with ground penetrating radar or another suitable non-destructive method is recommended to confirm the existence and size of any cavity. Corrective action includes injecting flowable fill or other suitable material into the cavity and monitoring the area for any signs of worsening condition. Investigation is strongly recommended to determine if corrective action is needed. A cavity in this location poses a significant risk and has potential to cause costly spillway failure if left unaddressed. This area was not examined during this inspection.

- For drains, is an animal guard installed at the outlet of each drain? Yes _____ No
 If no, which drains lack animal guards? /Corrective Action: The damaged animal guard at the toe drain located near the center of the downstream slope observed in previous inspections has not been repaired (See Photo 24), it is recommended that the bars be straightened and secured at the bottom of the pipe to function effectively Animal guards are missing from four of the spillway underdrains on the right side of the spillway (See Photo 43). Corrective action includes replacing missing animal guards.

43. Spillway face above plunge pool showing locations of toe drains with missing animal guards. Yellow circle shows general area of suspected void behind spillway face

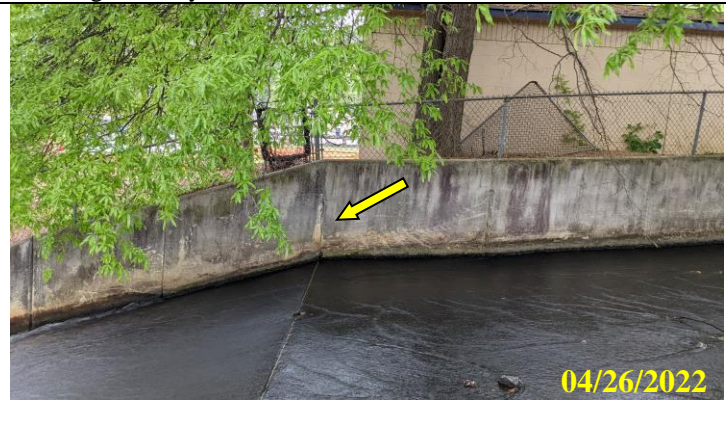
44. Cracked and missing concrete at top right of plunge pool face

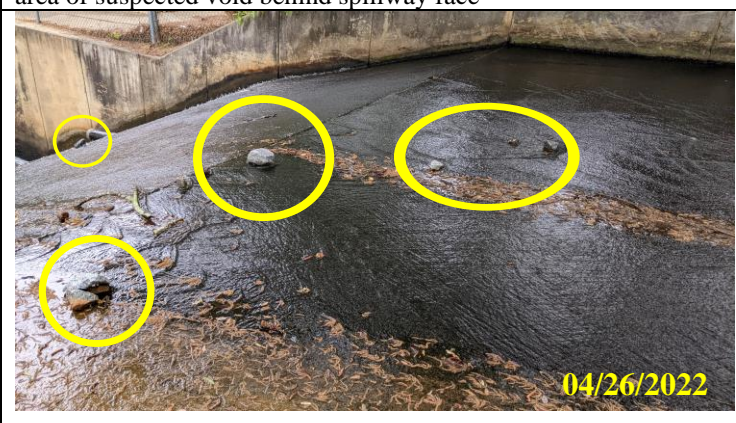
45. Riprap thrown into spillway
