Quarterly Dam Inspection Report

Murphey Candler Park Dam, City of Brookhaven

October 12, 2021

Embankment (Earth) Dam Inspection Form

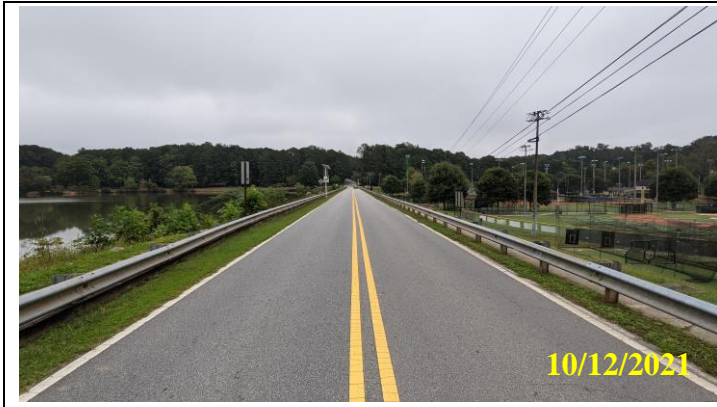
If yes, describe the condition (for example, good condition, numerous cracks, newly paved)/Corrective Action: The road is functional and in good condition (See Photos 1 and 2). Some minor cracks were observed on the paved road at a few locations as described in item 5 of this section (See Photos 3- 5).

1. Standing on crest of dam looking toward left abutment

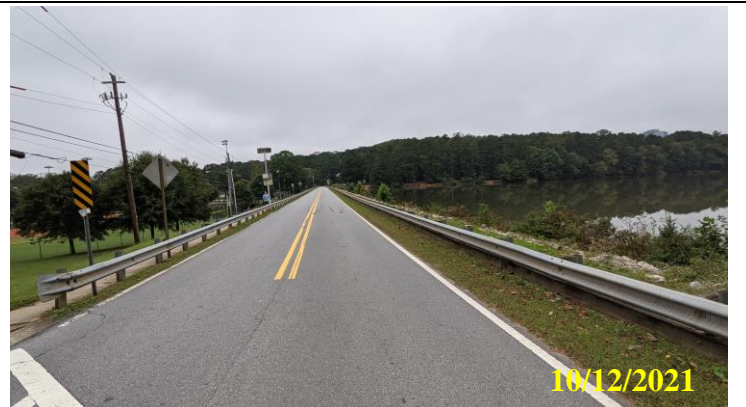
2. Standing on crest of dam looking toward right abutment

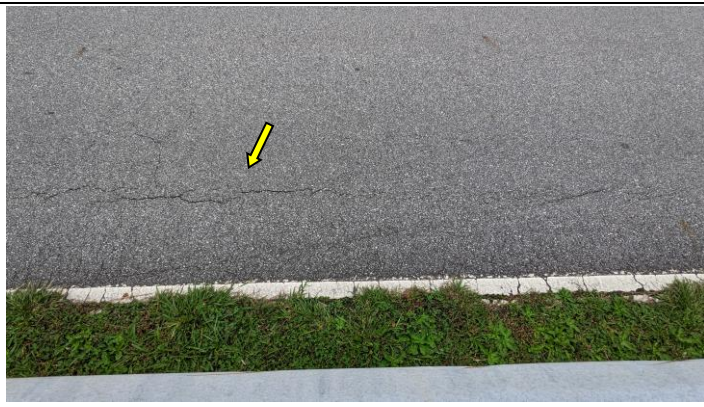
If yes, describe (length and width, location, direction of cracking, etc.)/Corrective Action: Several minor longitudinal cracks were observed towards the downstream edge of the roadway just left of the center of the dam (See Photos 3 and 4). Longitudinal cracking can be an indication of embankment slide, although there is no evidence that is the cause of these specific cracks. These cracks should continue to be monitored to ensure they do not increase in size or width, or otherwise worsen. The depressed area at the left, downstream edge of the dam crest (discussed in item 4 above) has created a semi-circular crack in the pavement (See Photo 5). These cracks should be monitored to ensure they do not increase in size or otherwise worsen.

3. Cracks in paved road on dam crest at left bridge abutment

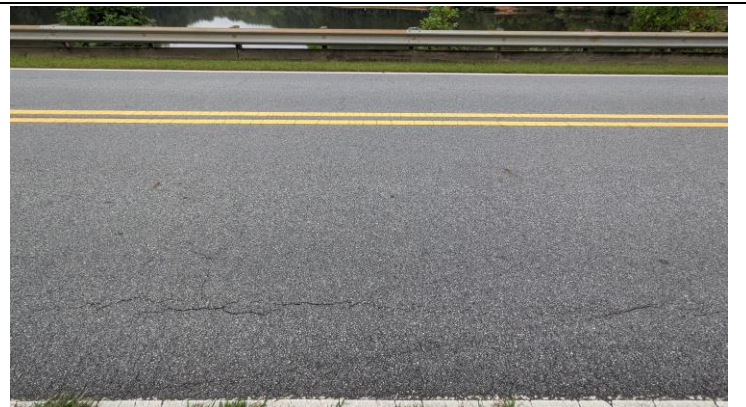
4. Additional crack in paved road on dam crest

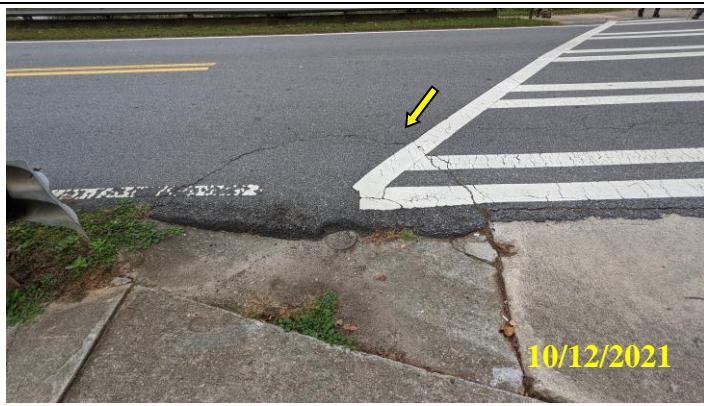
If yes, describe (size, location, etc.)/Corrective Action: There is a minor depression at the downstream left side of the crest by the end of the road guard rail. This depression appears unchanged since the previous report in July (See Photo 5). Cracks remain in the concrete sidewalk pavement and the asphalt road at this location. These do not appear to be in any area of critical concern but should continue to be monitored.

5. Depressed area on dam crest with crack on road pavement

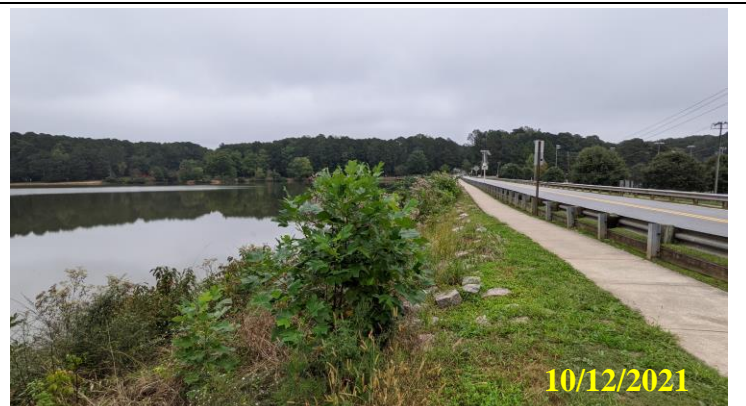
Other/Corrective Action (describe): The upstream slope is primarily covered with unevenly distributed riprap and vegetative growth. Thick vegetation on the upstream slope has continued to spread and is noticeably more dense than noted in the July 2021 inspection (See Photos 6 and 7).

6. View of upstream side looking towards left abutment

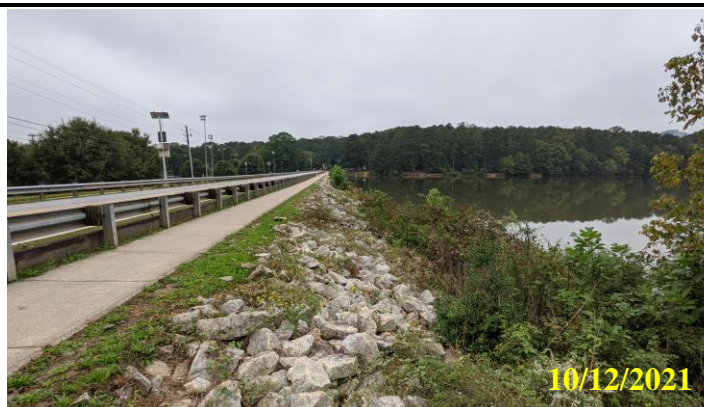
7. View of upstream side looking towards right abutment

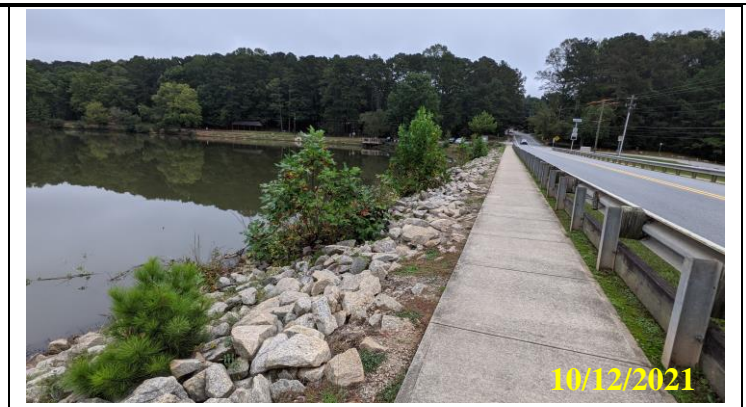
If yes, describe (type of vegetation, size, location, etc.)/Corrective Action: Woody vegetation remains that should be removed. Vegetation last observed in the July 2021 inspection has been allowed to continue growing (See Photos 6-10). Several young trees initially reported in the July 2020 inspection have not been removed and are continuing to mature (See Photo 10). As more vegetation is allowed to take root and mature on the upstream face of the dam the potential for damage caused by roots is increasing. It is recommended that woody vegetation and saplings be cut down to the base or extracted from their roots to prevent growing back in the future.

8. View of vegetation on upstream face of the dam

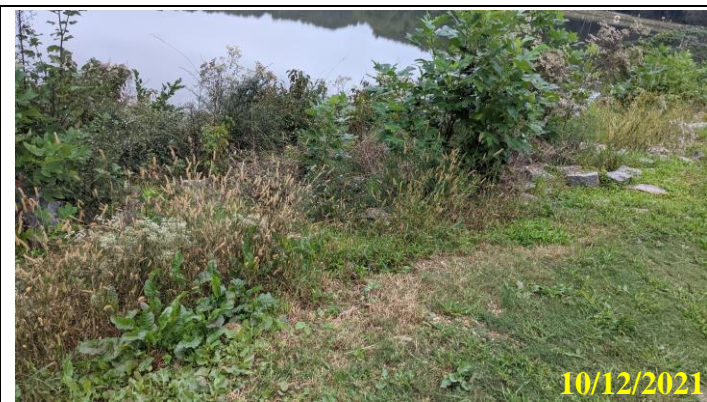
9. View of vegetation on upstream face of the dam

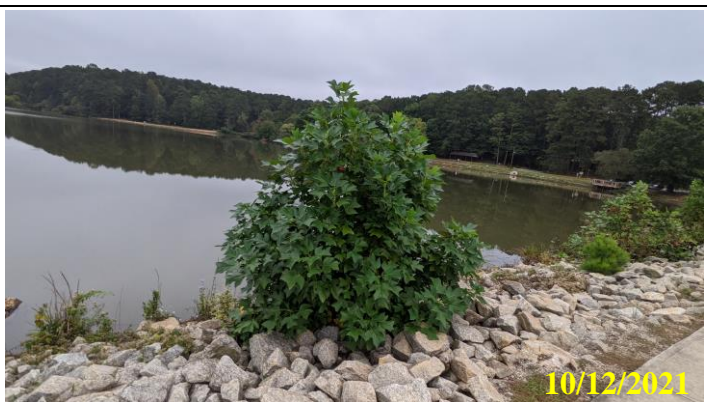
10. View of woody vegetation on upstream face of the dam

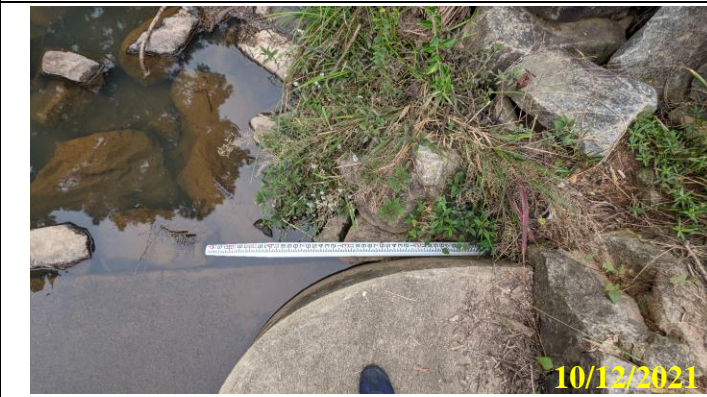
If yes, describe (size of area, location, severity, etc.)/Corrective Action: Significant erosion of the soil beneath the riprap continues to progress near the left wing wall of the concrete spillway. The erosion depth is up to 2-ft vertically in some locations immediately adjacent to the end of the left wing wall, comparison with previous inspection photos shows that 6 inches of soil have eroded since the December 2020 inspection in one location. (See Photos 11- 13). There is both undercutting and erosion perpendicular to the wall. Horizontal undercutting adjacent to the wing wall seen in Photo 11 has removed soil up to one foot under the wingwall. Future rain and high flow events can cause increased erosion and undercutting. Corrective actions are required and include filling and compacting the soil and near the concrete spillway. Repairs are necessary to prevent further erosion. There is insufficient riprap coverage in the area immediately adjacent to the right wing wall also, as noted in previous inspection reports (See Photos 27 and 30). Soil has started to erode from beneath the sidewalk on the upstream side of the dam crest as well, leaving a void several inches beneath the sidewalk in some places. (See Photo 21). Recommend backfilling soil in the void beneath the sidewalk and placing a filter material and additional well-graded riprap to prevent continued erosion.

11. Inadequate riprap grading at the left wing wall of the concrete spillway resulting in erosion and undercutting of riprap. See Photo 12 for location of this photo

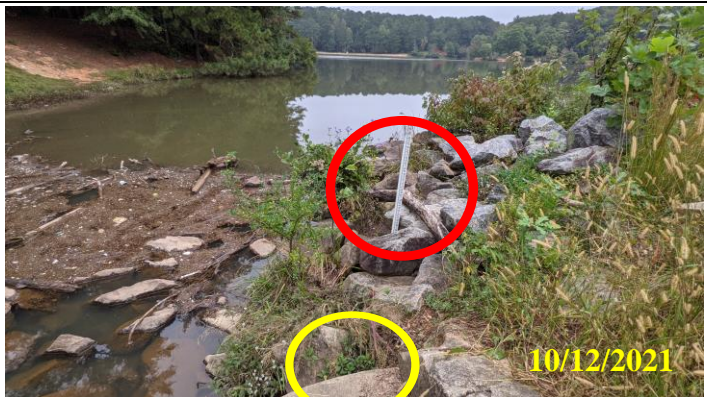
12. Inadequate riprap grading at the left wing wall of the concrete spillway resulting in erosion and undercutting of riprap. Yellow circled area is location of Photo 11 and red circled area is location of Photo 13

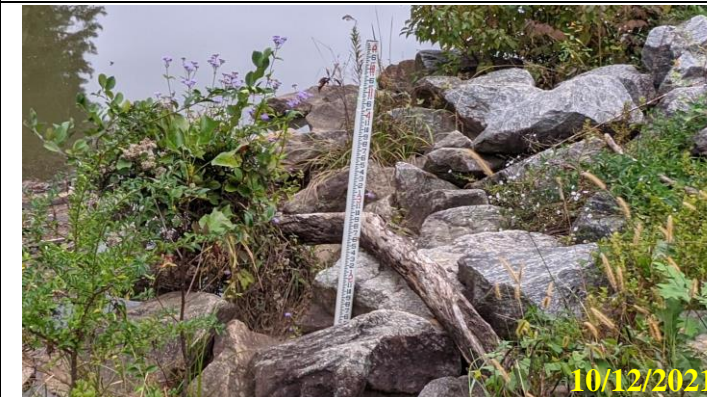
13. Inadequate riprap grading at the left wing wall of the concrete spillway resulting in erosion and undercutting of riprap

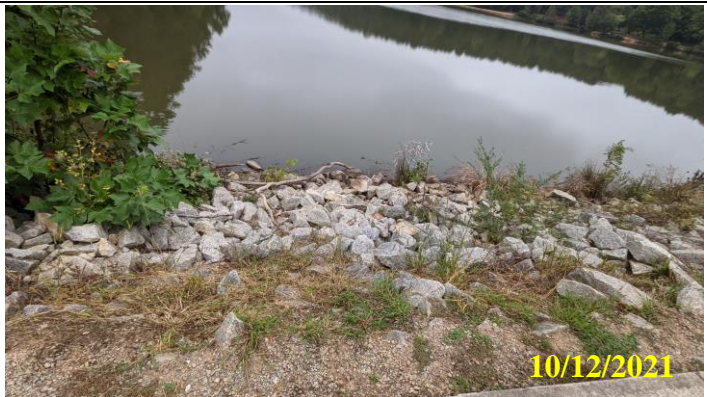
If yes, describe what type and its condition (for example, riprap - adequate, inadequate, sparse)/Corrective Action: Coverage of riprap is inconsistent across the width and height of the dam face (See Photos 6, 9, 14-16). The upper section of the dam face lacks adequate riprap coverage to provide protection at higher water levels. Recommend replacing riprap as needed across dam face to create uniform coverage up to sidewalk elevation. Notable areas include: 1) The right (west) side of the dam near the concrete spillway where it is visibly very sparse compared to the rest of the dam face (See Photo 15), 2) Several makeshift pathways leading from the pedestrian walkway to the water near the upstream left abutment and near the principle spillway riser (See Photo 16). Corrective action includes placing riprap along the dam face to create adequate uniform coverage of slope up to sidewalk elevation.

14. Sparse riprap near pedestrian walkway

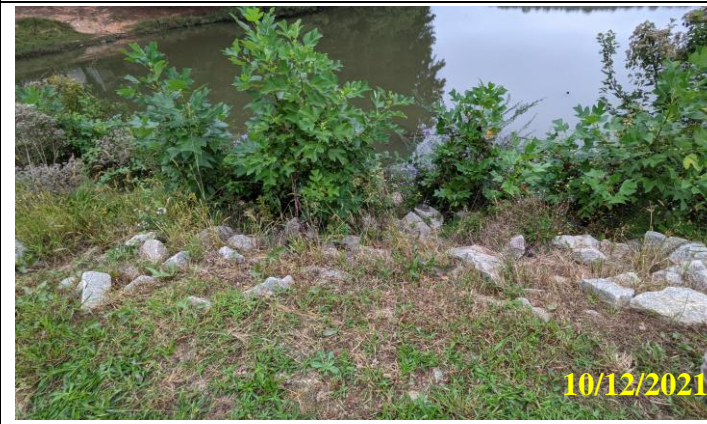
15. Sparse riprap coverage and uneven riprap sizing at right side of upstream dam face

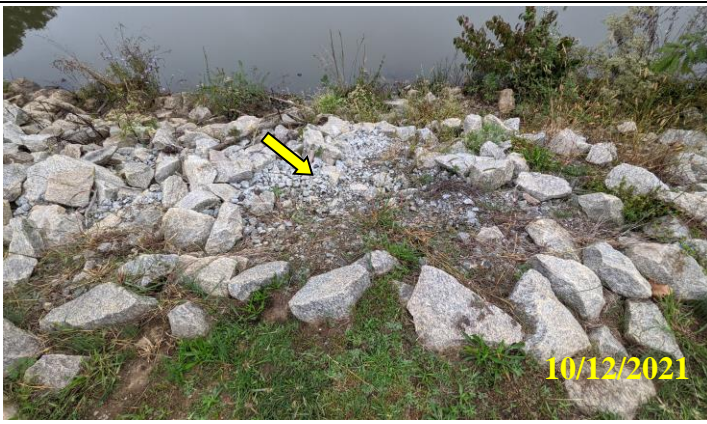
16. Pedestrian pathway showing sparse riprap near principal spillway riser

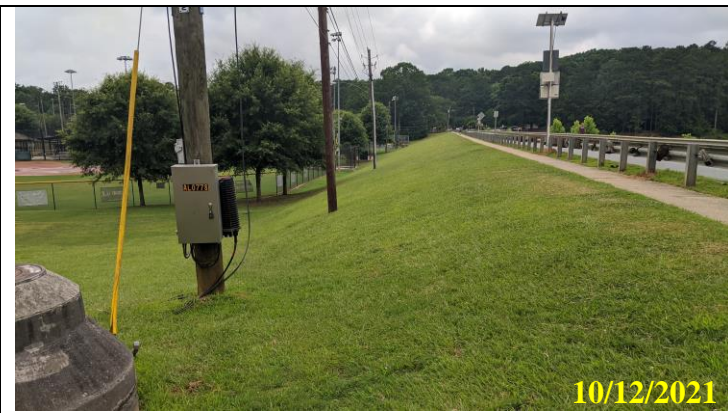
17. View of downstream slope looking toward right abutment

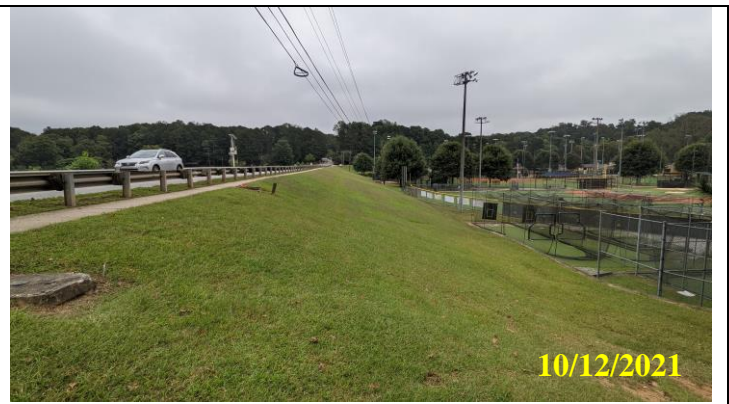
18. View of downstream slope looking toward left abutment

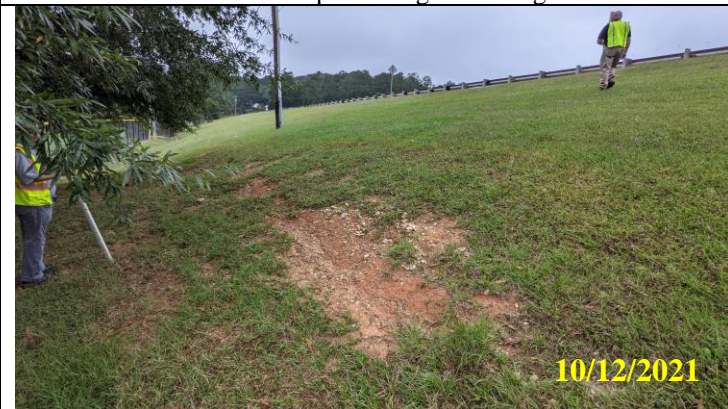
Other/Corrective Action (describe): The downstream slope of the dam is covered in well maintained recently mowed grass (See Photo 17 and 18). Several patches of missing grass on the right and left sides of the downstream slope have exposed the underlying soil (See Photos 19 and 20). Recommend these areas be re-seeded and monitored to ensure that they don't grow larger or lead to increased erosion.

19. Patches of missing grass on downstream dam face

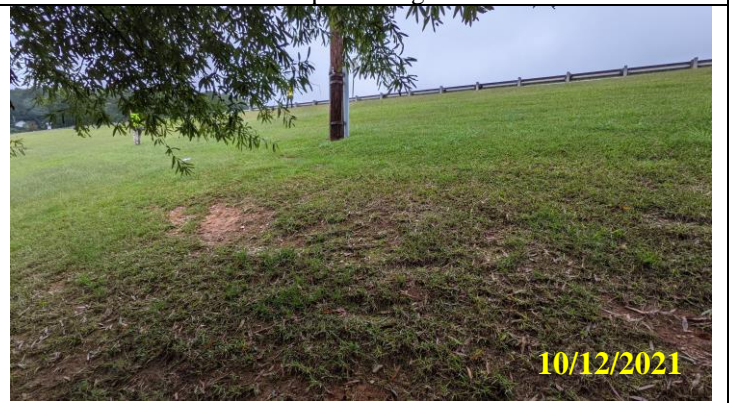
20. Patches of missing grass on downstream dam face

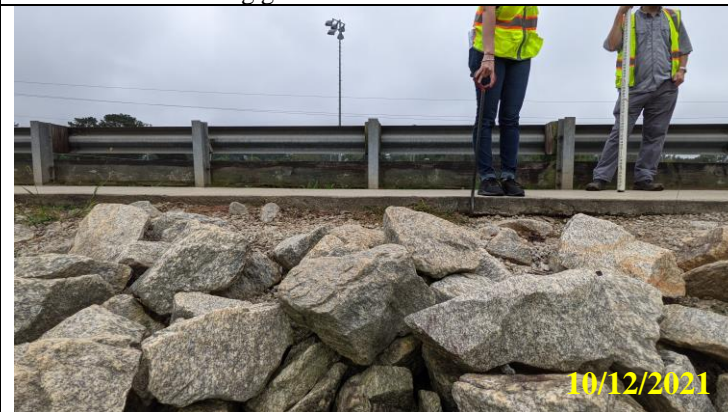
21. Minor undercutting and erosion at the pedestrian walkway on upstream dam crest

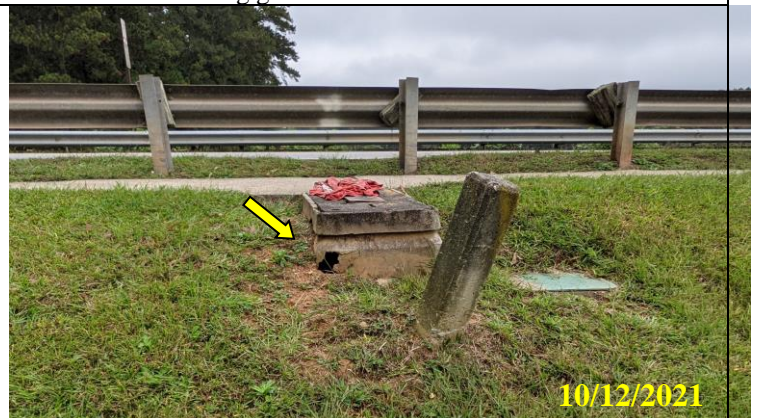
22. Damaged utility box on downstream face of dam

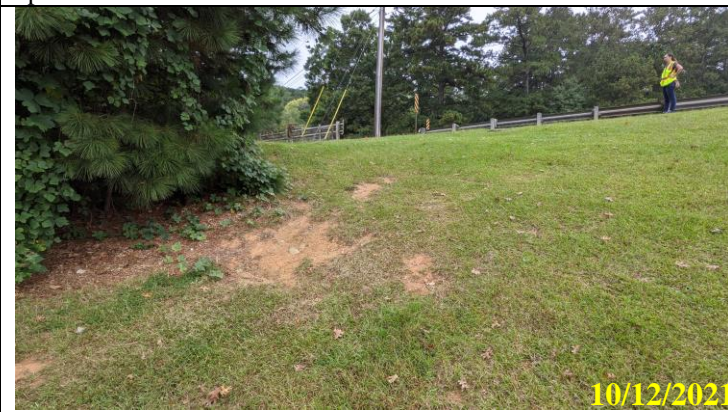
4. Are there any eroded areas on the slope (such as along abutment contacts)? Yes No _____
- If yes, describe (size of area, location, severity, etc.)/Corrective Action: Minor erosion/bare spots were observed in high-traffic areas such as near the sprinkler box, the batting cages, principal spillway outlet box and near the right downstream abutment (See Photo 23). Corrective actions in these areas includes filling in bare spots, compacting and grassing or adding a layer of gravel if grass continues not to grow.

23. Right side of downstream dam face showing erosion and missing grass

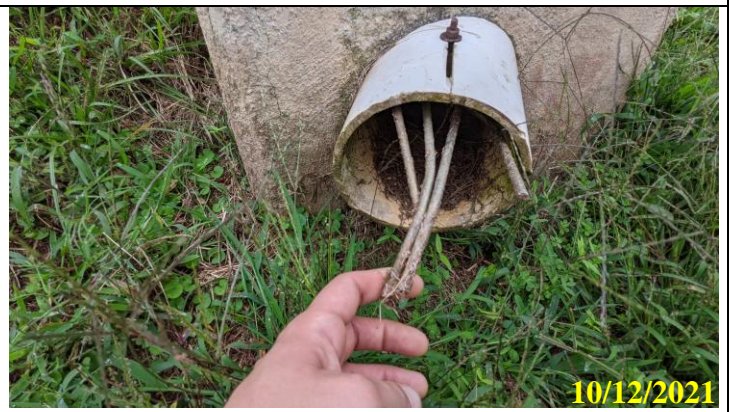
9. Other observations on the downstream slope/Corrective Action: An animal guard on the toe drain located roughly at the center of the downstream dam face should be straightened and secured from bottom to provide adequate barrier against small animals entering the drainpipe (See Photo 24). Previously noted minor damage to a utility box adjacent to a small concrete marker on the right side of the downstream face near the dam crest remains with no evidence of repair (See Photo 22). As previously noted, a hole has formed in the fiberglass structure on the downstream side of the box. This hole should be repaired to ensure erosion does not occur around the utility box. Once repaired, the soil around the box should be backfilled and compacted to avoid any future erosion.

If no, which drains lack animal guards? /Corrective Action: The damaged animal guard at the toe drain located near the center of the downstream slope observed in previous inspections has not been repaired (See Photo 24), it is recommended that the bars be straightened and secured at the bottom of the pipe to function effectively Animal guards are missing from three of the spillway underdrains on the right side of the spillway (See Photo 43). Corrective action includes replacing missing animal guards.

24. Toe drain at center of downstream dam face showing damaged animal guard

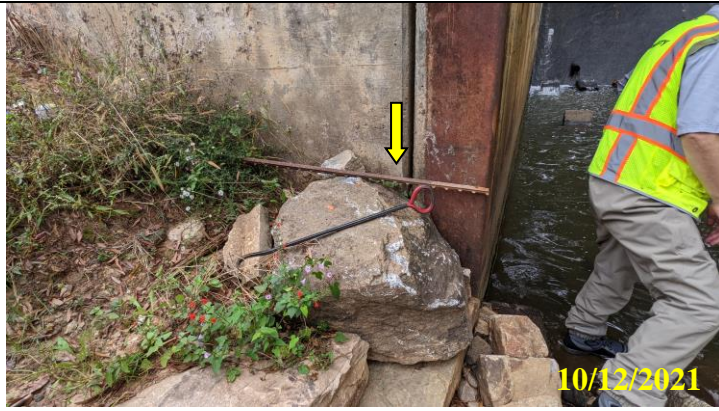
25. Toe drain at right side of plunge pool obscured by newly placed riprap

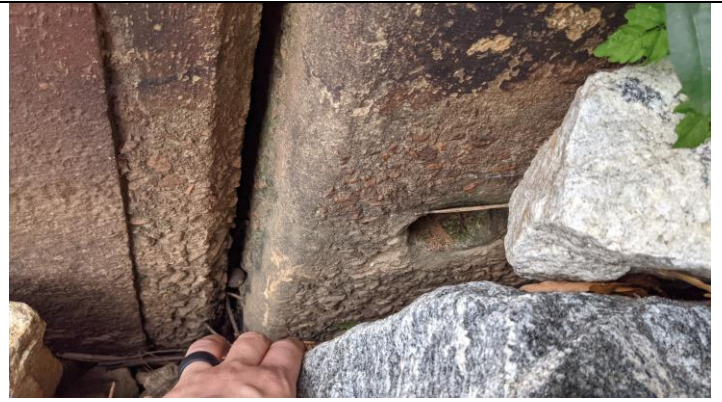
26. Matching toe drain on left side of plunge pool

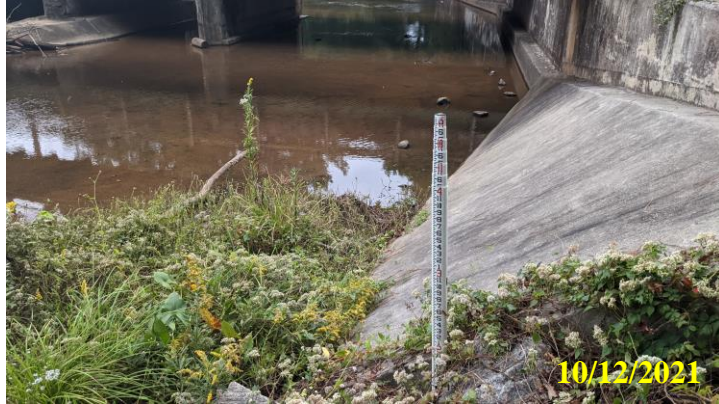
27. View of overgrown vegetation and sparse poorly graded riprap at the right upstream wingwall

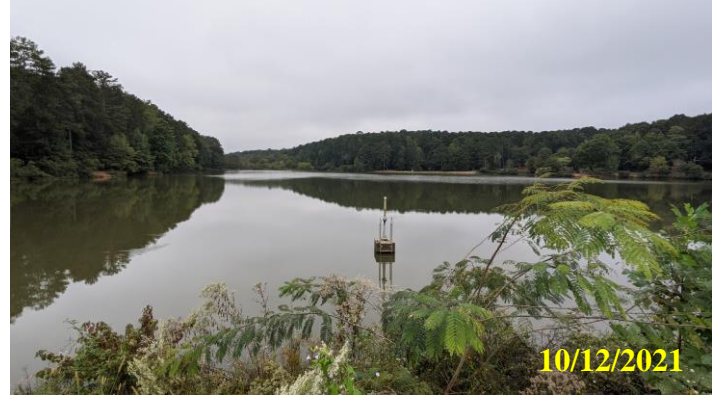
3. For pipe spillways, is the intake obstructed in any way (such as with excessive debris)? Yes _____ No
If yes, describe (type of debris, reason for obstruction, etc.) /Corrective Action: On 6/21/2017, DeKalb County Fire & Rescue divers inspected the principal upstream riser structure (See Photo 28). The divers did not identify any issues in the outer part of the riser or sluice gate. They did note that the orifice was buried in soft silt. An inspection has not been performed since. Wasps have built a nest inside the riser tube. The wasp nest should be removed to avoid potential hazards during any maintenance or emergency operation of the spillway riser.

28. Principal spillway riser

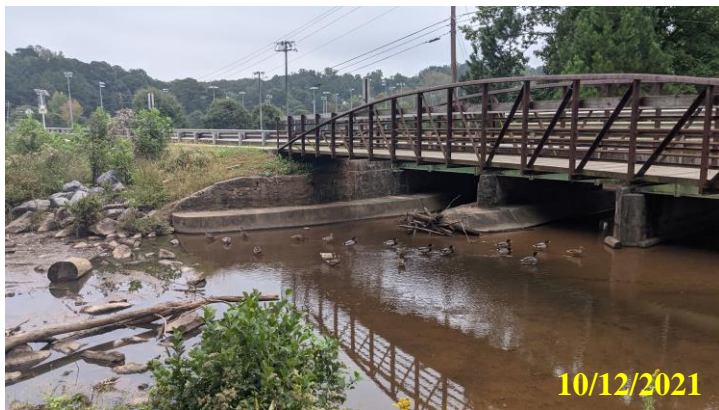
8. For concrete or earth channel spillways, is the entrance or channel obstructed in any way? Yes No _____
If yes, describe (type of obstruction, location, etc.) /Corrective Action: Minor amounts of woody debris have begun collecting at the upstream end of the spillway platform (See Photo 29). This debris should continue to be removed as it collects. The mat of grassy vegetation growing from the right bank into the concrete spillway was previously cleared but has begun growing back. Vegetation and silt are starting to collect again along the right side of the upstream spillway (See Photo 30). Grass should be periodically cut back and removed as it grows back to prevent increased accumulation of sediment and debris in the spillway. Grass has again begun growing in the concrete spillway. The concrete joint at this location also needs to be resealed, as noted in section 12 below (See Photo 35).

29. Woody debris accumulating in the upstream section of concrete spillway

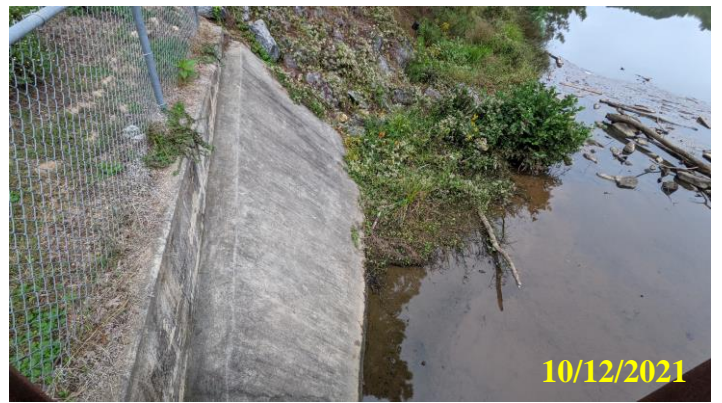
30. Vegetation and silt obstructing right side of upstream spillway. Sparse riprap along the right wing wall of the spillway

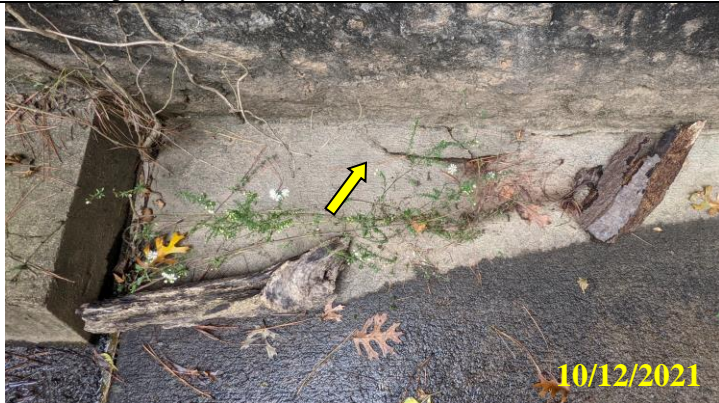
If yes, describe (width of crack or hole, location, etc.)/Corrective Action: The cutoff wall at the upstream face of the concrete spillway appeared to be in good condition and functioning well. 1) There are multiple areas of uplifting concrete at the joint of the spillway and the masonry wall on the left side of the flume downstream of West Nancy Creek Drive (See Photos 31- 33). Corrective action includes sealing the cracks to prevent widening or lengthening. Concrete is completely separated from one of these locations, leaving a hole 2 to 3 inches deep at the masonry wall joint (See Photo 33). Corrective action includes grouting and patching holes left behind by chipped or concrete spalls. 2) The caulk in the joints between the spillway bottom and the retaining walls along the left side of the spillway is missing or eroded over the majority of the spillway length (See Photos 32). Corrective action includes removing old caulk and reapplying caulk to the joints between the spillway base and the retaining walls of the spillway along its entire length. 3) Along the masonry retaining wall at the left side of the concrete spillway, there are cracks and areas missing grout between many of the stones(See Photo 36-39). Vines and other vegetation have resumed growing on the masonry wall directly downstream of West Nancy Creek Drive (See Photo 39). Corrective action includes removing any vegetation and re-grouting impacted areas. The prescribed repairs should be considered a provisional solution, and the aging masonry wall should eventually be replaced with a concrete wall. 4) Caulk between concrete slabs making up the spillway bottom is peeling and working loose from the lateral seams in multiple locations. The lateral seam directly upstream of the West Nancy Creek Drive bridge was observed to be undermined, and a cavity roughly 6 inches deep directly under the joint was observed. As noted in previous reports, caulk is also peeling from the lateral seam downstream of the bridge (See Photos 40 and 41). Corrective action includes removing old caulk and replacing with new caulk. 4) Concrete has completely separated from the bottom of a vertical crack at the top right of the plunge pool face (See Photo 44). This area of the spillway sees continuous flows, and the cracked concrete is a potential entry point for water to erode soil beneath the spillway. Corrective action includes sealing the cracks to prevent widening or lengthening. 5) Some of the trees and vegetation growing along the fence line on both sides of the spillway were previously cut back but have begun growing again (See Photos 39 and 42). Corrective action includes cutting/removing trees/vegetation including the remaining lower trunks of cut trees to prevent new growth. Any holes must be filled and compacted. It is recommended that any trees within 15 feet of the spillway walls be removed. Grass was observed growing between lateral seams in the spillway (See Photo 35). All grassy vegetation should be cleared from the spillway channel and joints resealed. Previously completed repairs to spillway slab adjacent to concrete wall appear to be holding up well (See Photo 34).

31. Concrete spillway cracking and uplift at masonry wall joint

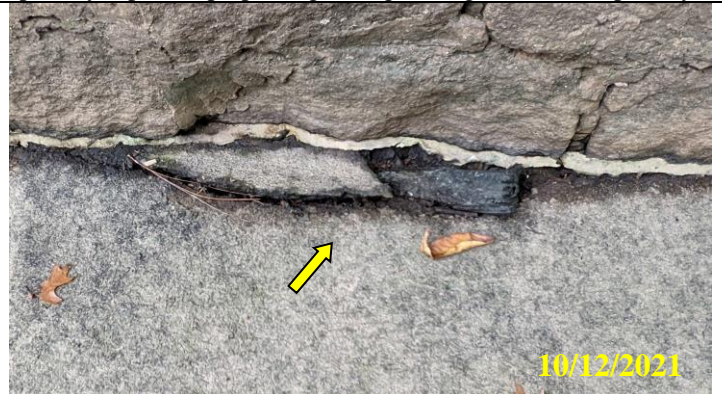
32. Concrete spillway cracking and uplift at masonry wall joint with exposed seal

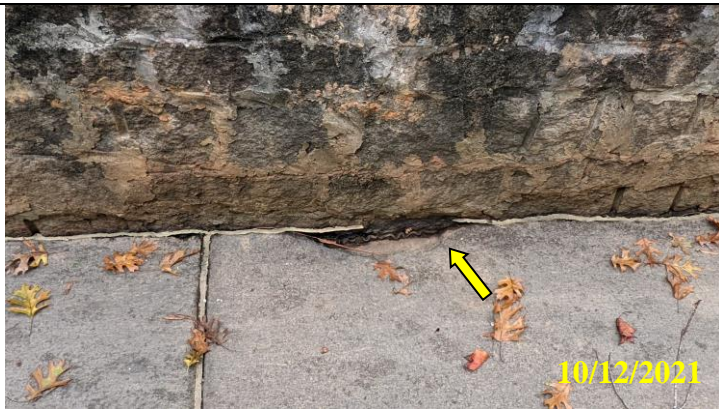
33. Concrete spillway cracking and spalling concrete at masonry wall joint

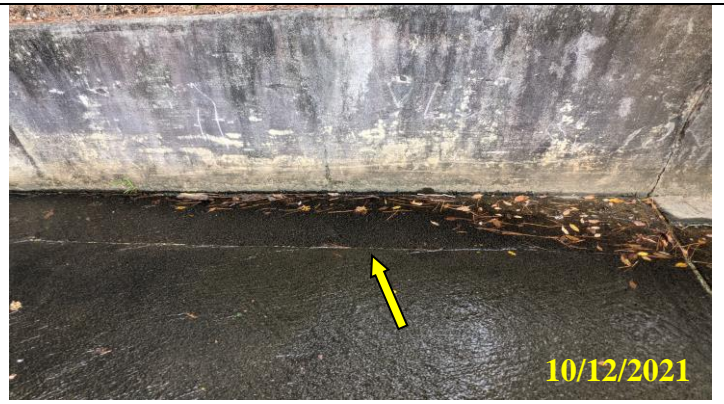
34. Previously completed repairs to spillway upholding well

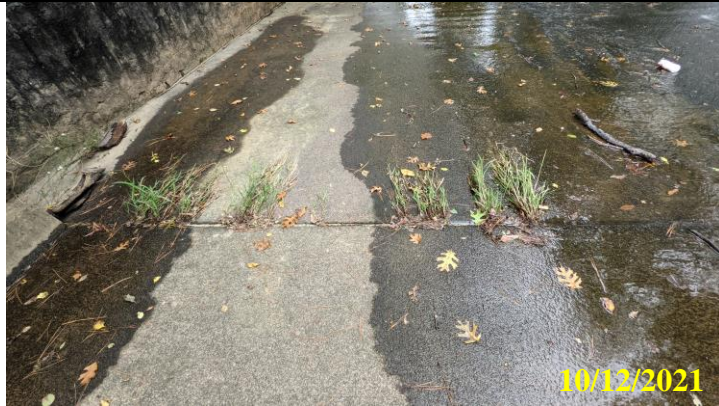
35. Grass growing between slabs in concrete spillway

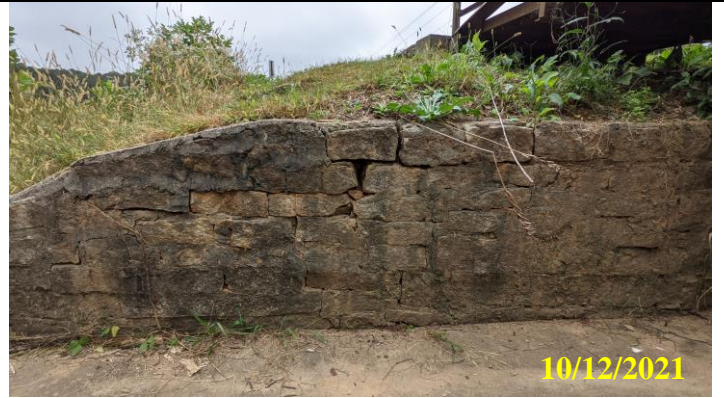
36. Missing grout and cracks in masonry wall at spillway entrance

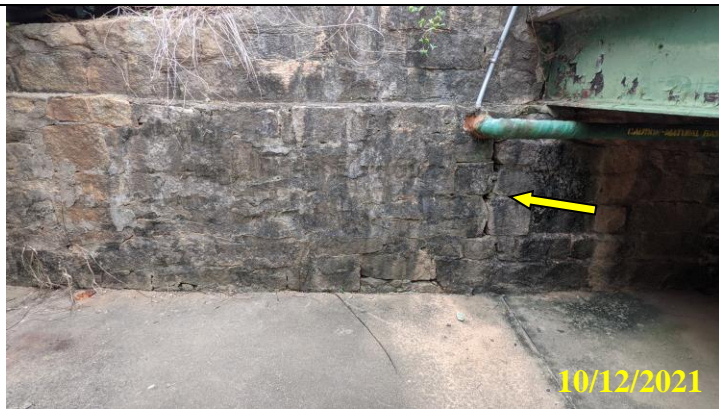
37. Missing grout in masonry wall at bridge crossing

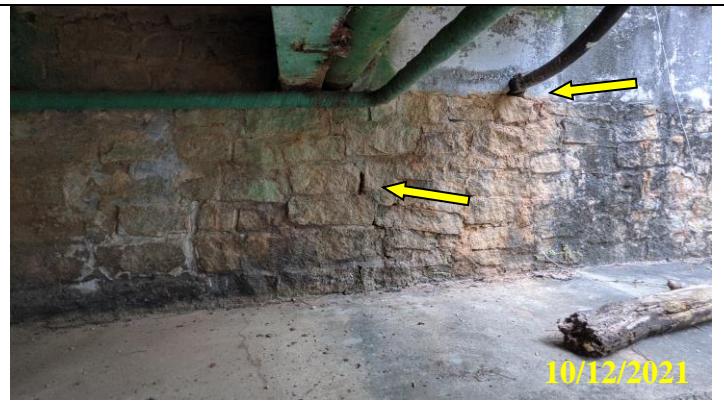
38. Missing grout in masonry wall at bridge crossing

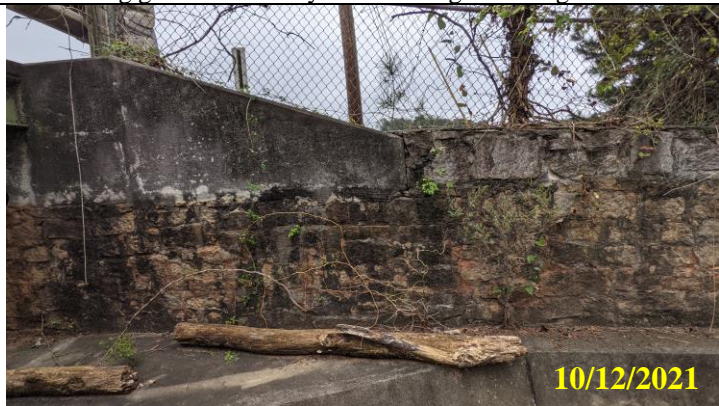
39. Vines and vegetations on masonry wall downstream of bridge crossing

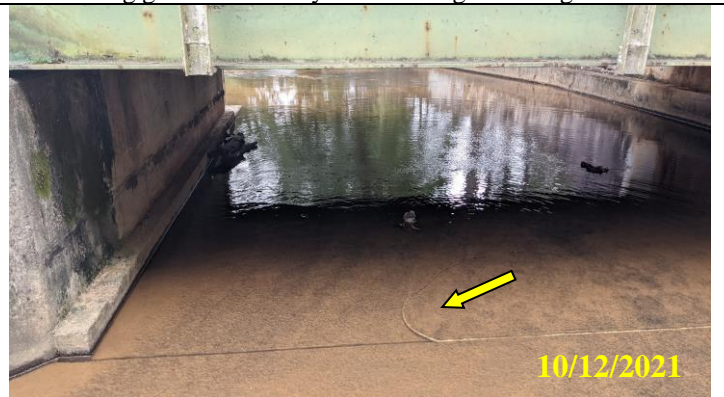
40. Caulking peeling from between spillway slabs at bridge crossing

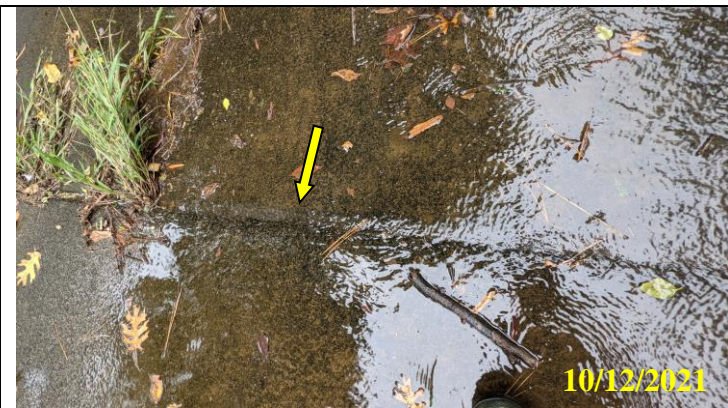
41. Caulk peeling from between spillway slabs downstream of bridge crossing

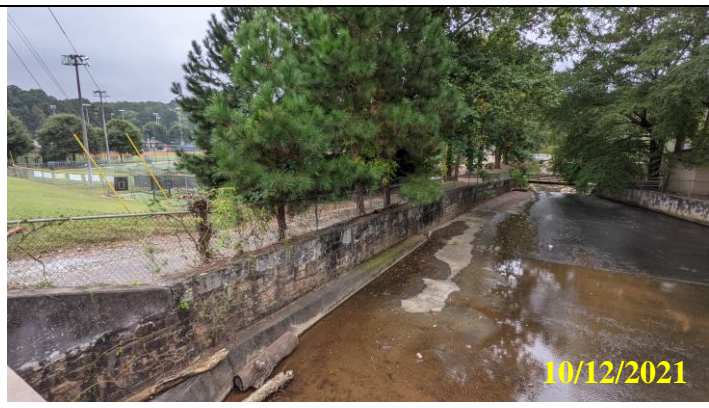
42. Trees at spillway fence

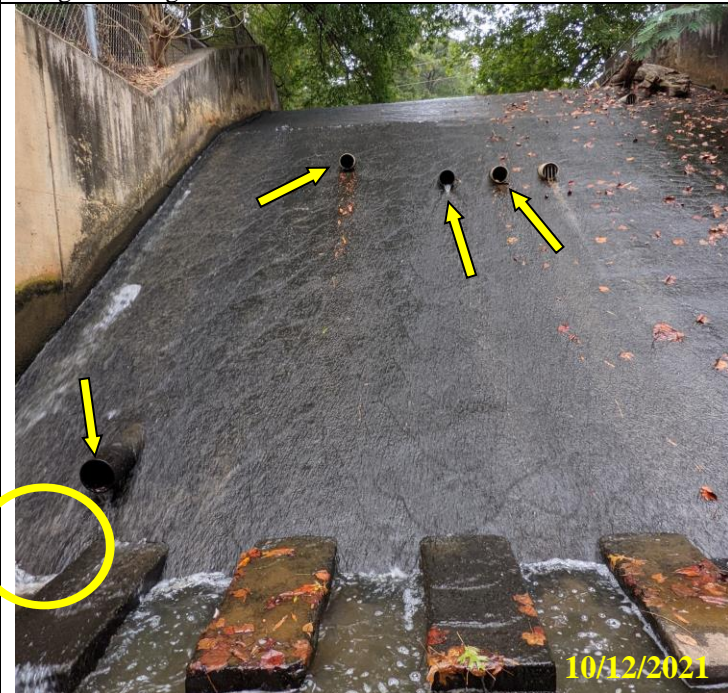
2. Is there any erosion and or seeps around or going into the plunge pool? Yes No _____
- If yes, describe (size of area, location, severity, etc.) /Corrective Action: There is potentially a cavity forming beneath the lower right (west) face of the spillway directly above the plunge pool (See Photo 43). During the December 2019 and October 2021 inspections, striking the face of the spillway with a survey rod produced a hollow tone in this location, distinct from solid sounds produced by striking elsewhere on the spillway. There is no readily apparent cause of the cavity. Further investigation with ground penetrating radar or another suitable non-destructive method is recommended to confirm the existence and size of any cavity. Corrective action includes injecting flowable fill or other suitable material into the cavity and monitoring the area for any signs of worsening condition. Investigation is strongly recommended to determine if corrective action is needed. A cavity in this location poses a significant risk and has potential to cause costly spillway failure if left unaddressed. This area was not examined during this inspection.

43. Spillway face above plunge pool showing locations of toe drains with missing animal guards. Yellow circle shows general area of suspected void behind spillway face

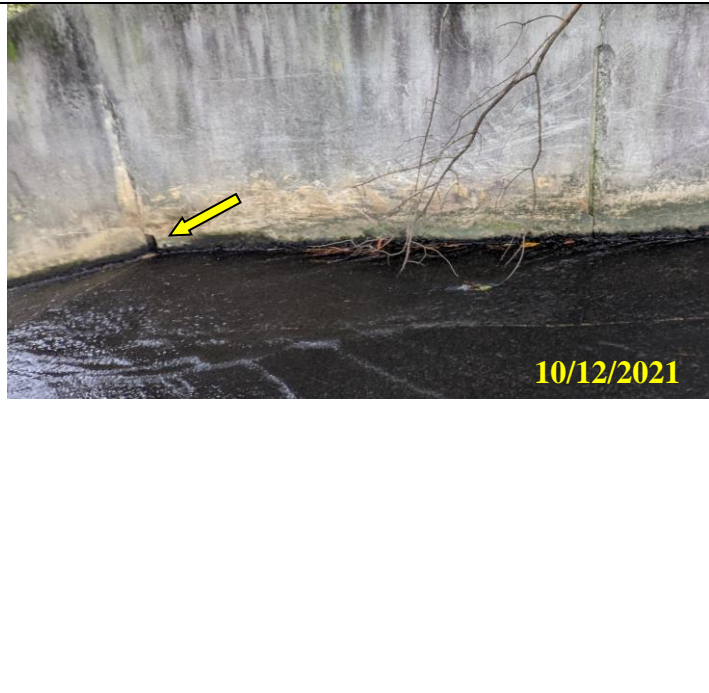
44. Cracked and missing concrete at top left of plunge pool face
