Quarterly Dam Inspection Report

Murphey Candler Park Dam, City of Brookhaven

December 14, 2020

Embankment (Earth) Dam Inspection Form

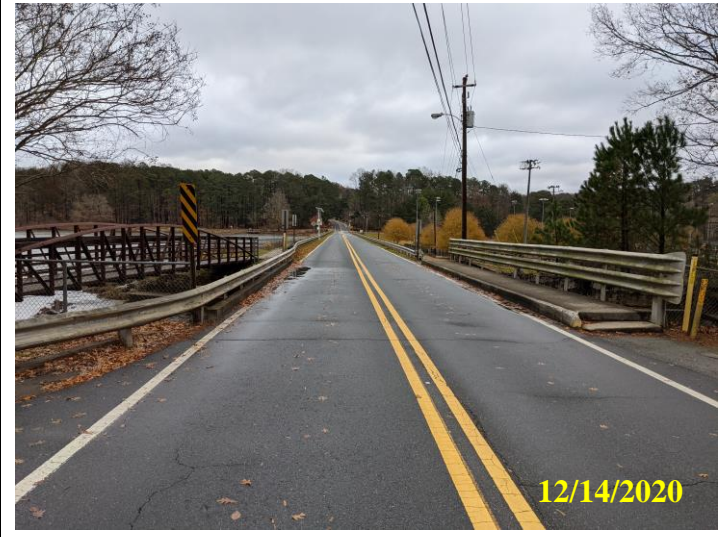
If yes, describe the condition (for example, good condition, numerous cracks, newly paved)/Corrective Action: The road is functional and in good condition (See Photos 1 and 2). Some minor cracks were observed on the paved road at a few locations as described in section 5 of this report (See Photos 3- 5).

1. Standing on crest of dam looking towards left abutment

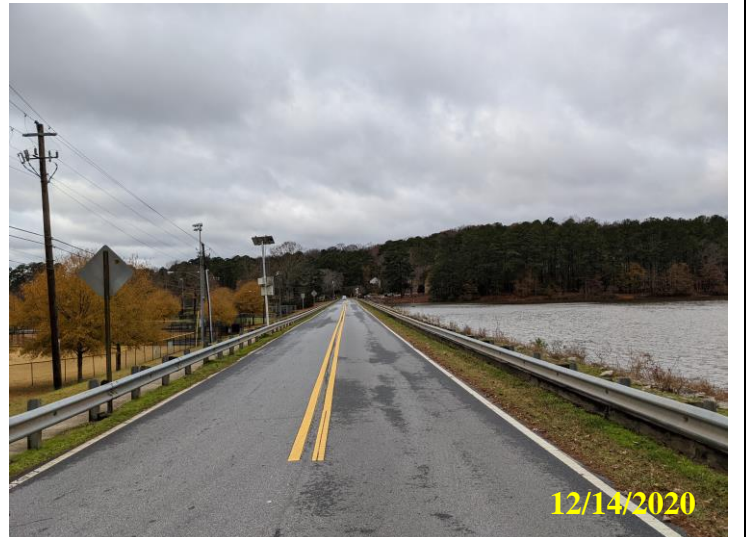
2. Standing on crest of dam looking toward right abutment

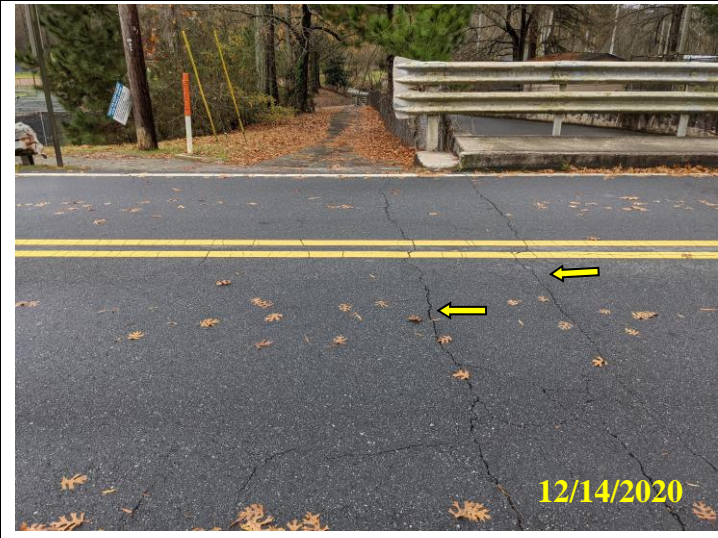
If yes, describe (length and width, location, direction of cracking, etc.)/Corrective Action: The cracks in the paved road on the dam crest noted most recently in the September inspection remain. There is no indication they have grown wider. Existing cracks located on the left end of the bridge measuring approximately 17-ft and 13-ft in length (See Photo 3) are similar in appearance to last inspection. A crack in the centerline of the roadway running parallel to the direction of the dam was also observed near the left (east) end of the dam. This crack should be monitored to ensure it does not increase in size or otherwise worsen. (See Photo 4). Depressed area at the left, downstream edge of the dam crest has created a semi-circular crack in the pavement. (See Photo 5). All cracks appear to be unchanged since September inspection. These cracks should be monitored to ensure they do not increase in size or otherwise worsen.

3. Cracks in paved road on dam crest at left bridge abutment.

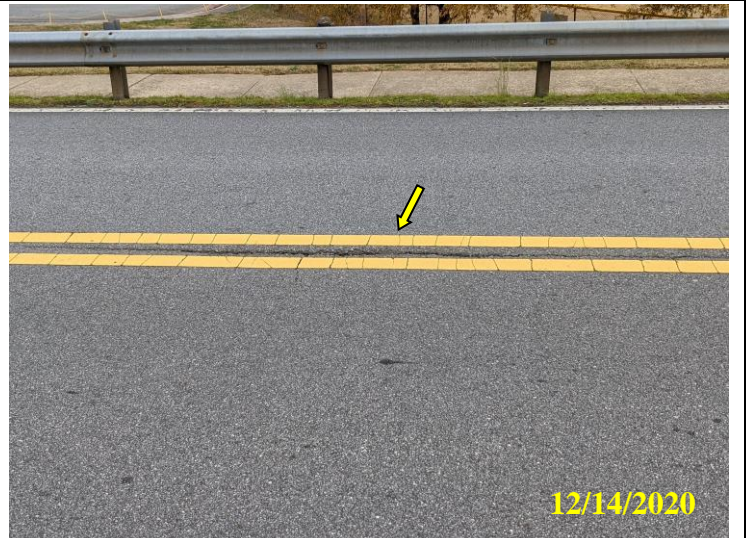
4. Additional crack in paved road on dam crest.

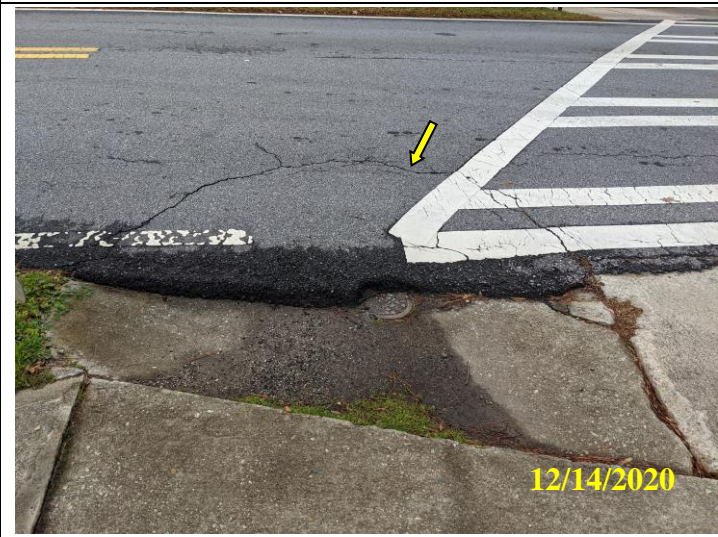
If yes, describe (size, location, etc.)/Corrective Action: There is a minor depression at the downstream left side of the crest by the end of the road guard rail. This depression appears unchanged since the previous report in September. (See Photo 5). Cracks remain in the concrete sidewalk pavement and the asphalt road at this location. These do not appear to be in any area of critical concern but should continue to be monitored.

5. Depressed area on dam crest with crack on road pavement

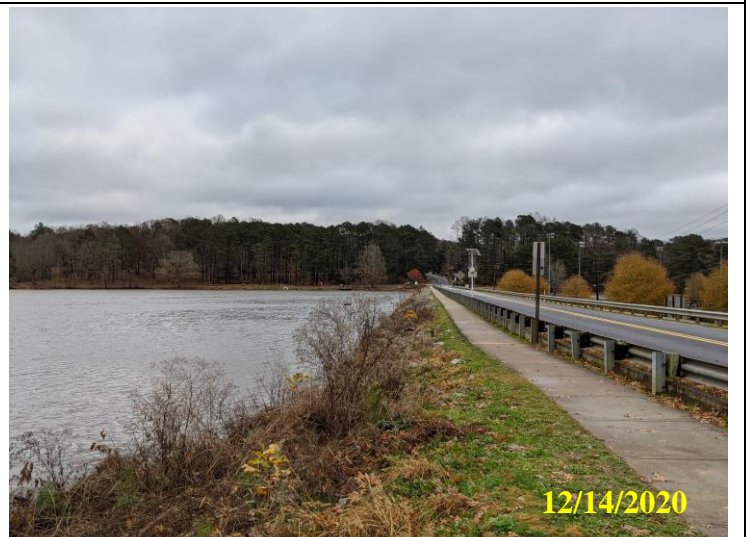
Other/Corrective Action (describe): The upstream slope is primarily covered with unevenly distributed riprap and vegetative growth. The vegetation on the upstream slope was noticeably sparser than September inspection, although this appears to be due to die back from recent low temperatures as opposed to maintenance performed to remove vegetation. (See Photos 6 and 7).

6. View of upstream side looking towards left abutment.

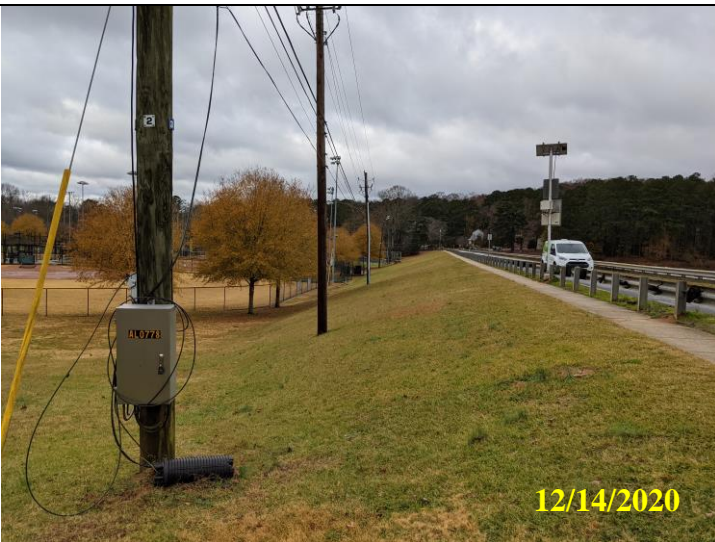
Other/Corrective Action (describe): The downstream slope of the dam is covered in well maintained recently mowed grass (See Photo 17 and 18). Several patches of missing grass on the right side of the downstream slope have exposed the underlying soil (See Photos 19 and 20). Recommend these areas be re-seeded and monitored to ensure that they don't grow larger or lead to increased erosion.

17. View of downstream slope looking toward right abutment

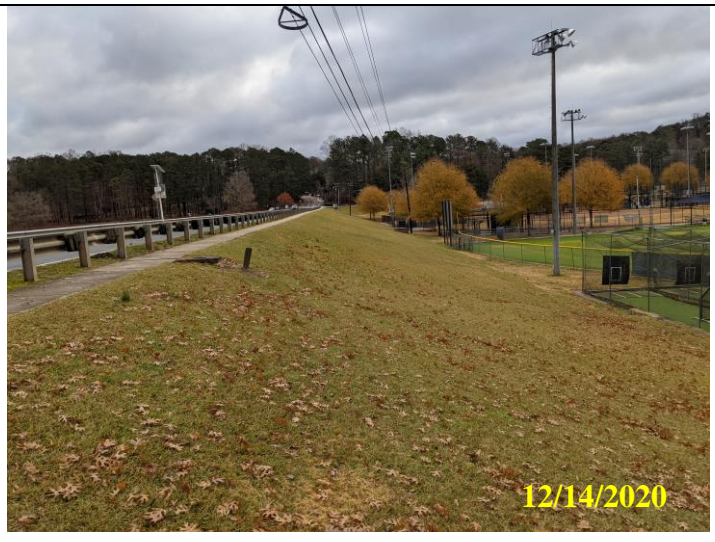
18. View of downstream slope looking toward left abutment

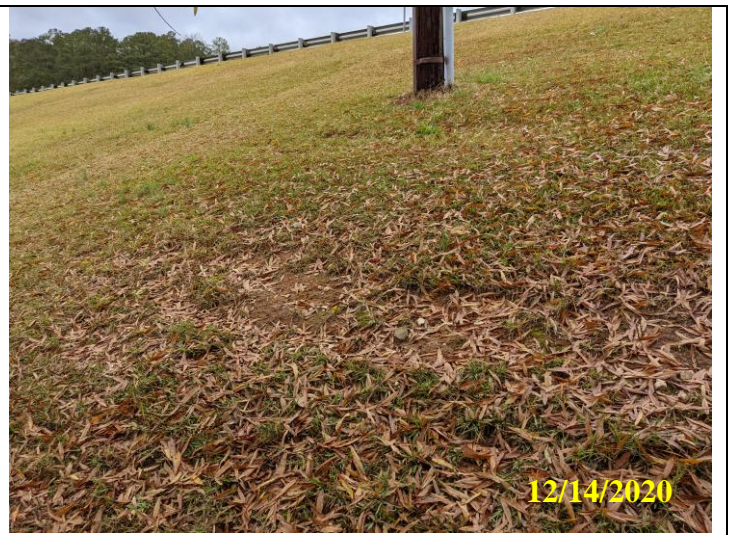
20. Patches of missing grass on downstream dam face

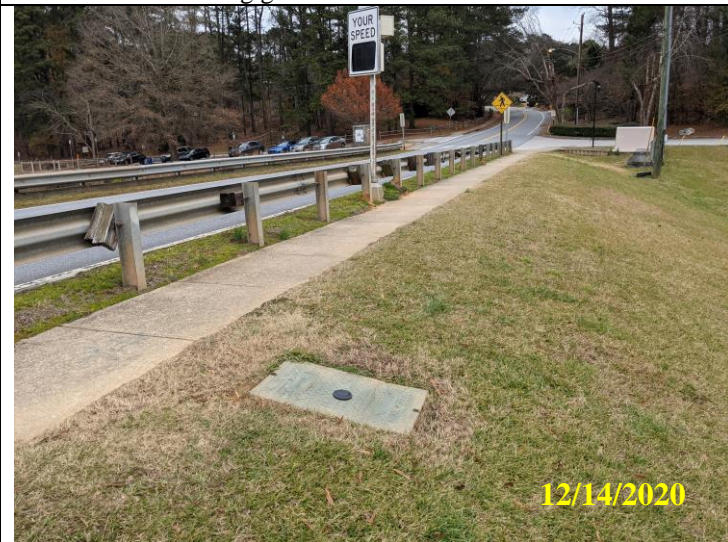
If yes, describe (size, location, etc.)/Corrective Action. The repairs to the damaged utility box adjacent to the electronic speed sign and surrounding soil appear to be holding up well with no signs of erosion. (See Photo 21).

21. Repaired utility box on downstream face of dam

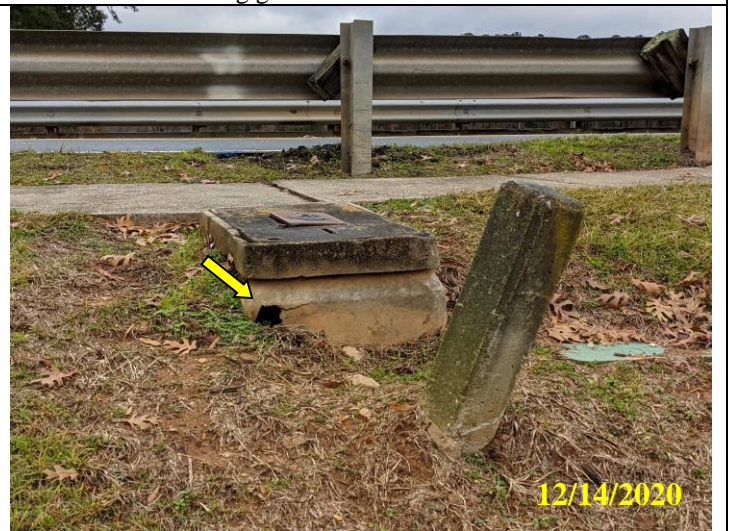
22. Damaged utility box on downstream face of dam

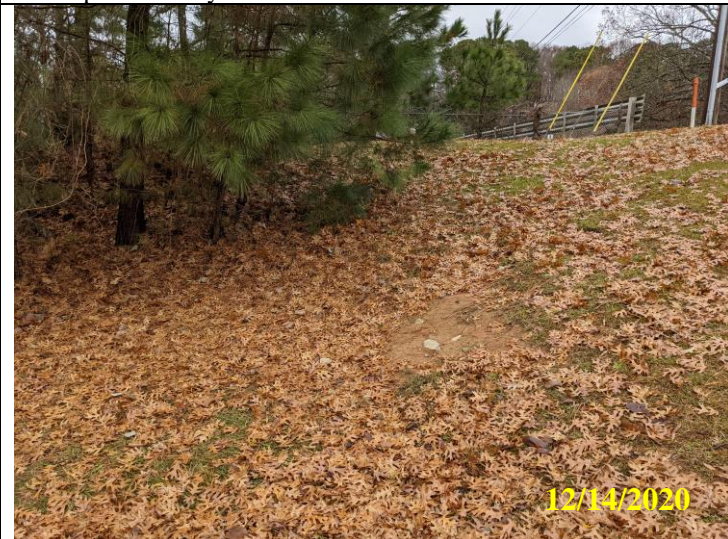
If yes, describe (size of area, location, severity, etc.)/Corrective Action: Minor erosion/bare spots were observed in high-traffic areas such as near the sprinkler box, the batting cages, principal spillway outlet box and near the right downstream abutment (See Photo 23). Corrective actions in these areas includes filling in bare spots, compacting and grassing or adding a layer of gravel if grass continues not to grow.

23. High traffic area at right side of downstream dam face showing erosion and missing grass

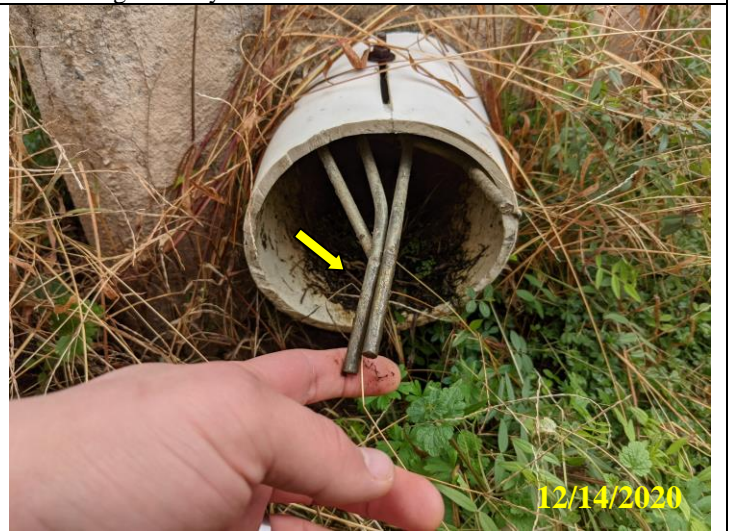
9. Other observations on the downstream slope/Corrective Action: An animal guard on the toe drain located roughly at center of downstream dam face should be straightened and secured from bottom to provide adequate barrier against small animals entering the drain pipe (See Photo 24). Previously noted minor damage to a utility box adjacent to a small concrete marker on the right side of the downstream face near the dam crest remains with no evidence of repair. (See Photo 22). A hole has formed in the fiberglass structure on the downstream side of the box. This hole should be repaired to ensure erosion does not occur around the utility box. Once repaired, the soil around the box should be backfilled and compacted to avoid any future erosion.

If no, which drains lack animal guards? /Corrective Action: The damaged animal guard at the toe drain located near the center of the downstream slope observed in previous inspections has not been repaired (See Photo 24), it is recommended that the bars be straightened and secured at the bottom of the pipe to function effectively Animal guards are missing from three of the spillway underdrains on the right side of the spillway (See Photo 43). Corrective action includes replacing missing animal guards.

24. Toe drain at center of downstream dam face showing damaged animal guard.

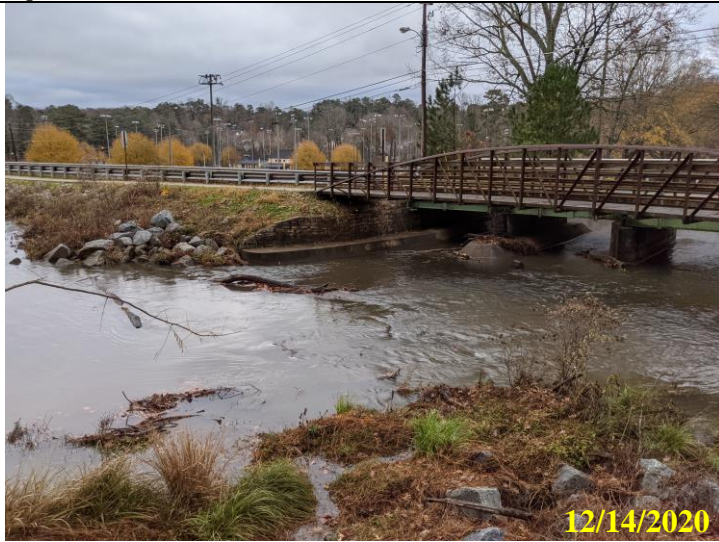
2. Has the emergency spillway activated (had flow) since the last inspection? Yes ✓ No _____
If yes describe (date(s) of flow, reason for activation, depth of flow) /Corrective Action: The emergency spillway experiences continuous service flows (See Photo 27).

27. View of concrete spillway upstream of bridge crossing

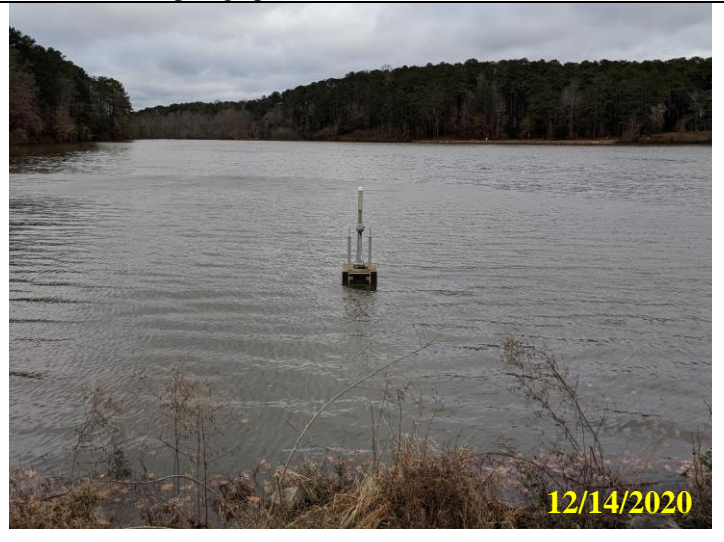
3. For pipe spillways, is the intake obstructed in any way (such as with excessive debris)? Yes _____ No ✓
If yes, describe (type of debris, reason for obstruction, etc.) /Corrective Action: On 6/21/2017, DeKalb County Fire & Rescue divers inspected the principal upstream riser structure (See Photo 28). The divers did not identify any issues in the outer part of the riser or sluice gate. They did note that the orifice was buried in soft silt. An inspection has not been performed since. Wasps have built a nest inside the riser tube. The wasp nest should be removed to avoid potential hazards during any maintenance or emergency operation of the spillway riser.

28. Principal spillway riser

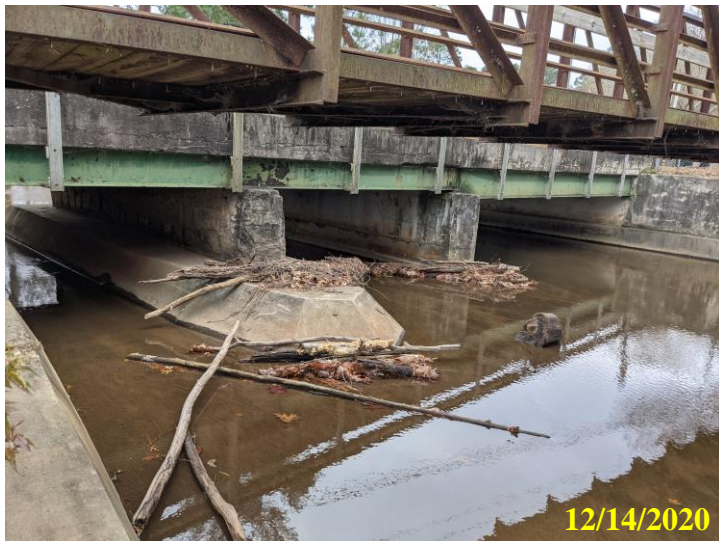
29. Small amount of woody debris accumulation in the upstream section of concrete spillway

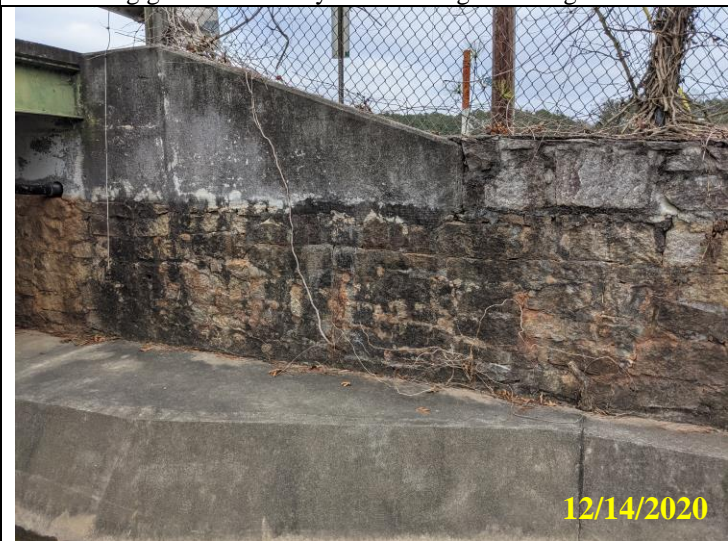
39. Remains of vines and vegetations on masonry wall downstream of bridge crossing

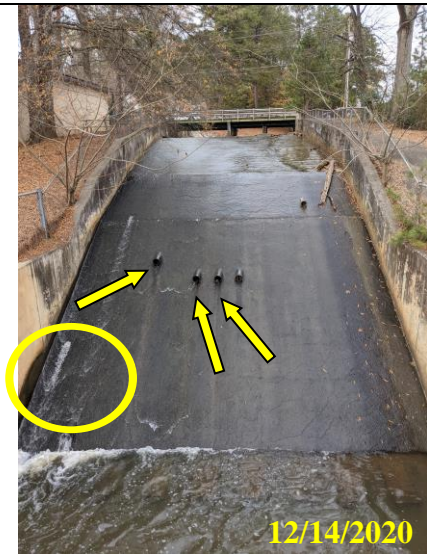
If yes, describe (size of area, location, severity, etc.) /Corrective Action: There is potentially a cavity forming beneath the lower right (west) face of the spillway directly above the plunge pool (See Photo 43). During the December 2019 inspection striking the face of the spillway with a survey rod produced a hollow tone in this location, distinct from solid sounds produced by striking elsewhere on the spillway. There is no readily apparent cause of the cavity. Further investigation with ground penetrating radar or other suitable non-destructive method is recommended to confirm the existence and size of any cavity. Corrective action includes injecting flowable fill or other suitable material into the cavity and monitoring the area for any signs of worsening condition. Investigation is strongly recommended to determine if corrective action is needed. A cavity in this location poses a significant risk and has potential to cause costly spillway failure if left unaddressed. This area was not examined during this inspection.

Minor flows were observed from some spillway underdrains but were not measured due to access (See Photo 43). A small toe drain at the right side of the plunge pool was observed to be emitting a rust colored liquid (See Photo 25). This may be evidence of rusted or otherwise compromised pipes, possibly related to the potential void behind the face of the plunge pool wall.

43. Spillway face above plunge pool showing locations of toe drains with missing animal guards, yellow circle shows general area of suspected void behind spillway face

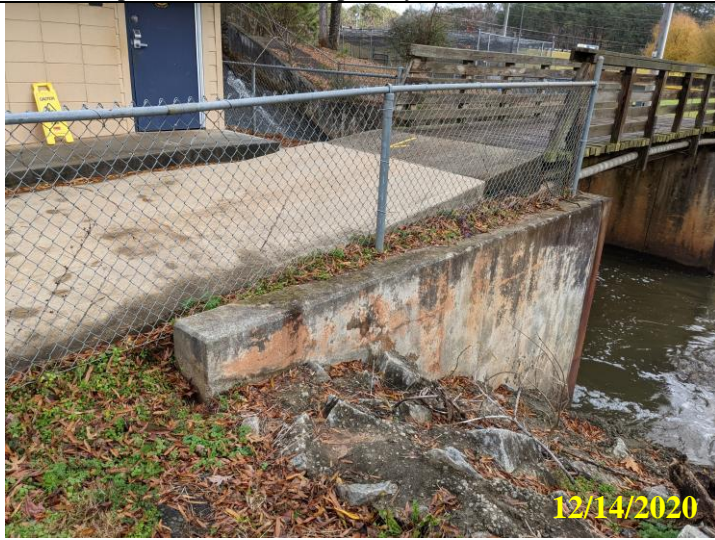
45. Location of Photo 44

If yes, describe (width of crack or hole, location, etc.)/Corrective Action: The cutoff wall at the upstream face of the concrete spillway appeared to be in good condition and functioning well. There are multiple areas of uplifting concrete at the joint of the spillway and the masonry wall on the left side of the flume downstream of West Nancy Creek Drive (See Photos 31- 33). Corrective action includes sealing the cracks to prevent widening or lengthening. Concrete is completely separated from one of these locations, leaving a hole 2 to 3 inches deep at the masonry wall joint (See Photo 33). Corrective action includes grouting and patching holes left behind by chipped or concrete spalls. 2) The caulk in the joints between the spillway bottom and the retaining walls along the left side of the spillway is missing or eroded over the majority of the spillway length (See Photo 32). Corrective action includes removing old caulk and reapplying caulk to the joints between the spillway base and the retaining walls of the spillway along its entire length. 3) Along the masonry retaining wall at the left side of the concrete spillway, there are cracks and areas missing grout between many of the stones. Vines and other vegetation previously observed growing on the masonry wall appears to have died back due to low temperatures but may return in warmer months (See Photos 36- 39). Corrective action includes removing any vegetation and re-grouting impacted areas. The prescribed repairs should be considered a provisional solution and the aging masonry wall should eventually be replaced with a concrete wall. 4) Caulk between concrete slabs making up the spillway bottom is peeling and working loose from the lateral seams in multiple locations. The lateral seam directly upstream of the West Nancy Creek Drive bridge was observed to be undermined and a cavity roughly 6 inches deep directly under the joint was observed. As noted in previous reports, caulk is also peeling from the lateral seam downstream of the bridge. (See Photos 40 and 41). Corrective action includes removing old caulk and replacing with new caulk. 4) Some of the trees and vegetation growing along the fence line on both sides of the spillway were previously cut back (See Photos 42). . . Previously noted regrowth has halted due to lower temperatures but is likely to continue in warmer months. Corrective action includes cutting/removing trees/vegetation including the remaining lower trunks of cut trees to prevent new growth. Any holes must be filled and compacted. It is recommended that any trees within 15 feet of the spillway walls be removed. Grass previously observed growing between lateral seams in the spillway slabs has died back in the colder weather but will likely return in warmer months (See Photo 35). All grassy vegetation should be cleared from the spillway channel and joints resealed. Previously completed repairs to spillway slab adjacent to concrete wall appear to be holding up well (See Photo 34). The right wing wall downstream of the plunge pool is showing beginnings of minor erosion at the top edges (See Photos 44-45). This area should be backfilled and compacted and monitored to ensure the erosion does not worsen.
