Listed in order of priority. Most projects reflect a HIGH PRIORITY status from MS4 inspections, while others have been identified by other means. Prioritization takes into account the following factors: Condition, relative stability of condition, location, consequence of failure (public safety, safety of structures, impact of failure on public, emergency access, etc.), construction disruption and difficulty, and probable cost.

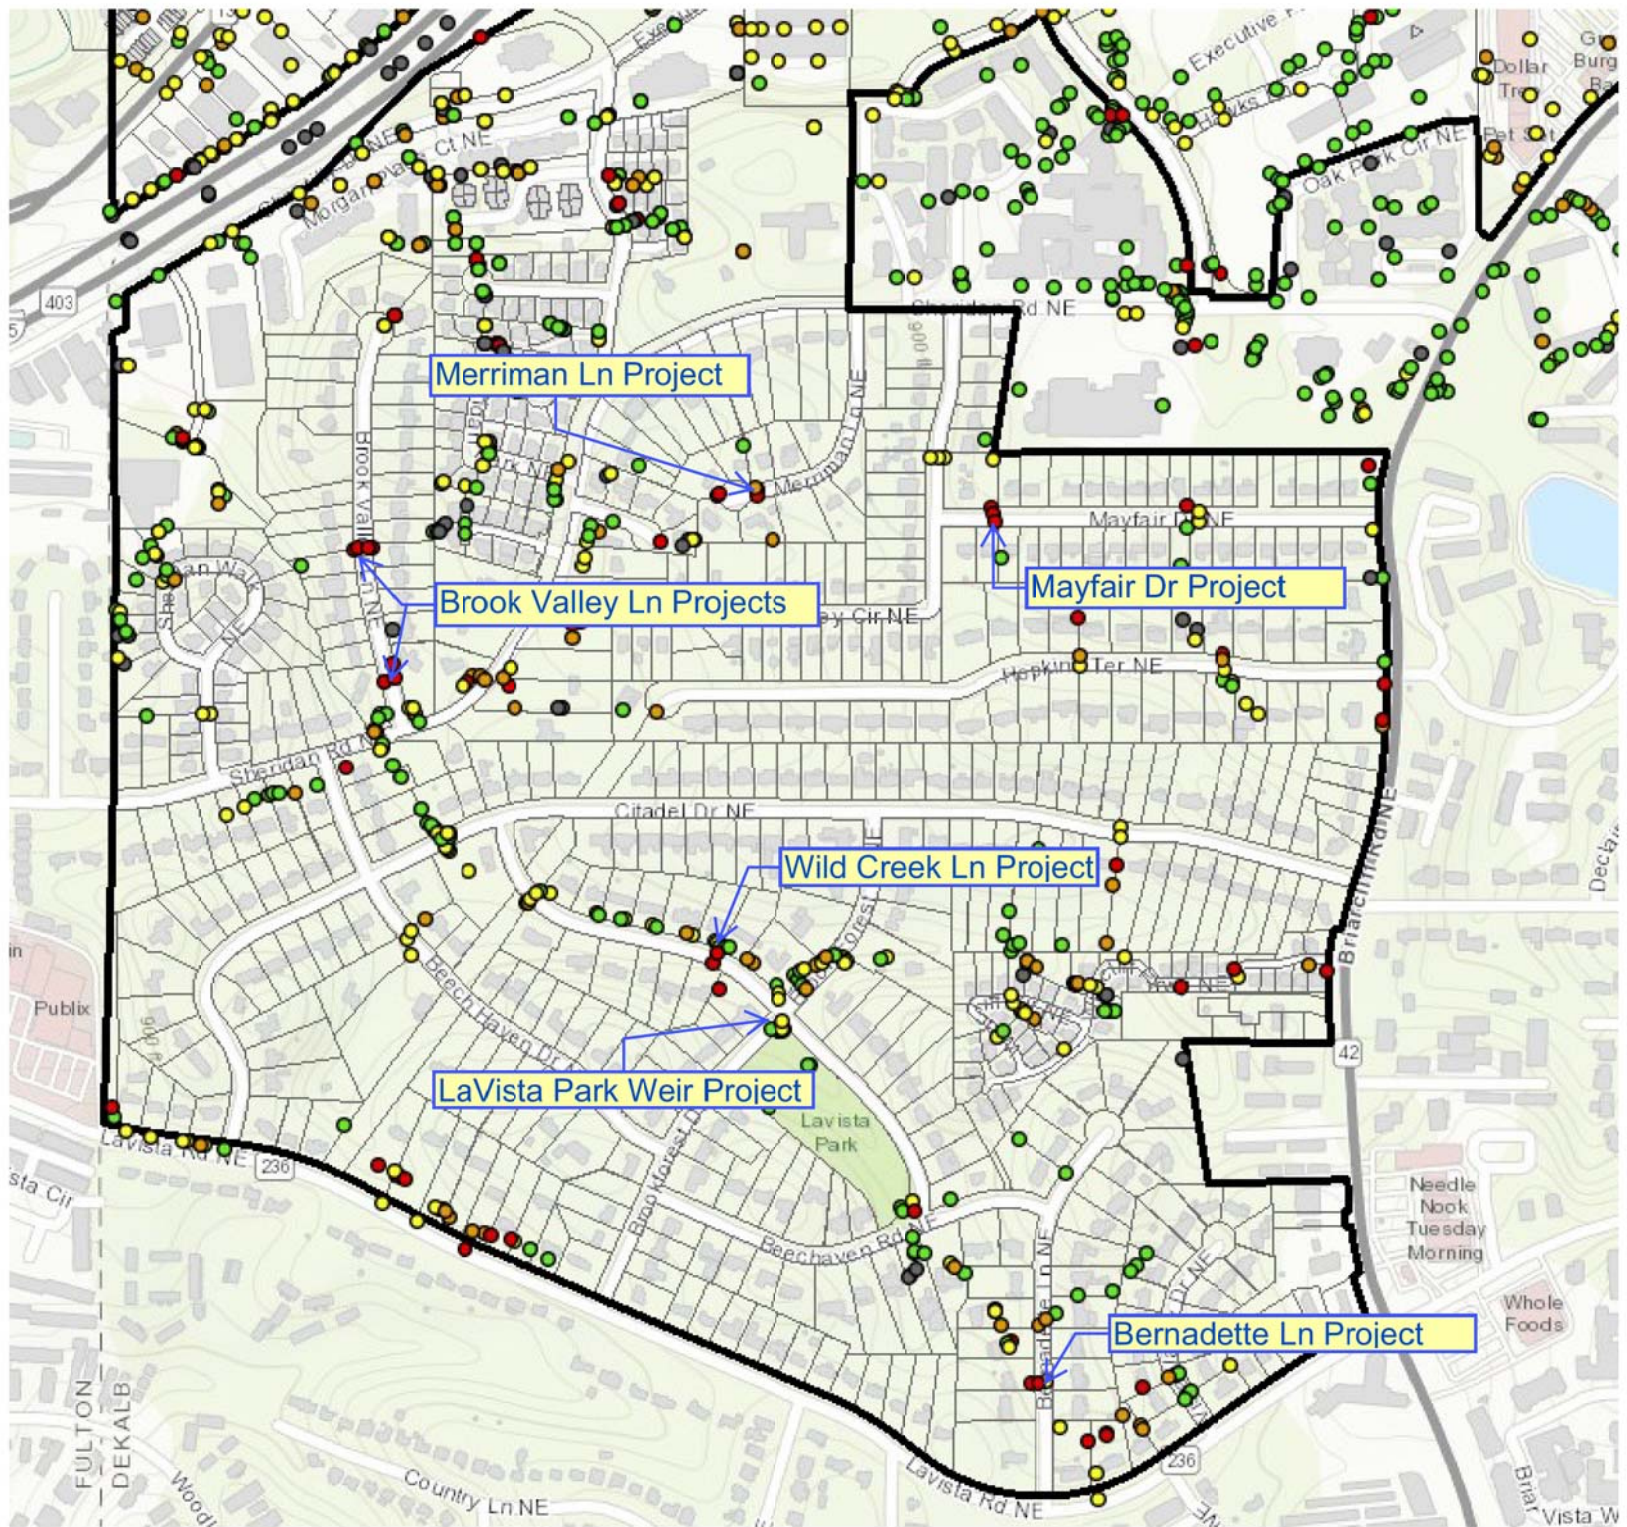
Forest Dr) in LaVista Park has eroded and requires rehabilitation. The weir was installed by DeKalb County several years ago but not maintained.
